Seven Mile Beach, Grand Cayman

Beach restoration and shoreline management

Mathematical modelling studies and analyses

Draft Final Report
Project No 11829049

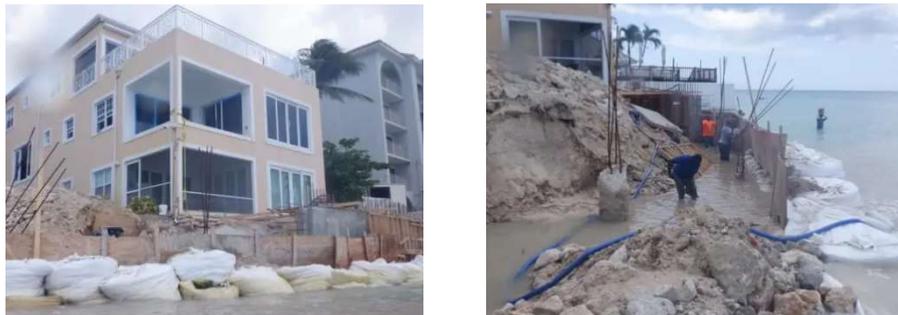
Figure 1-1 Observed damage to coastal infrastructure and emergency protection works in an attempt to mitigate the problem.

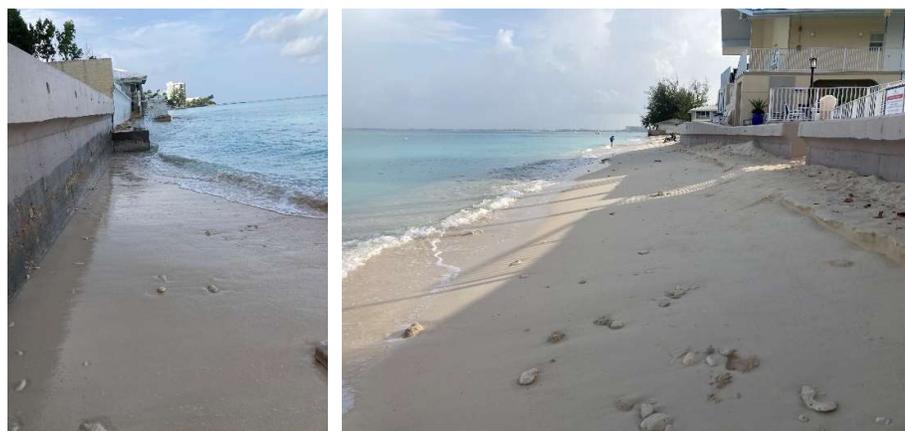
Figure 1-2 Severe beach erosion at Cayman reef resort, 2023. On the right photo the location of the water line during a recent high-water event can be noticed.

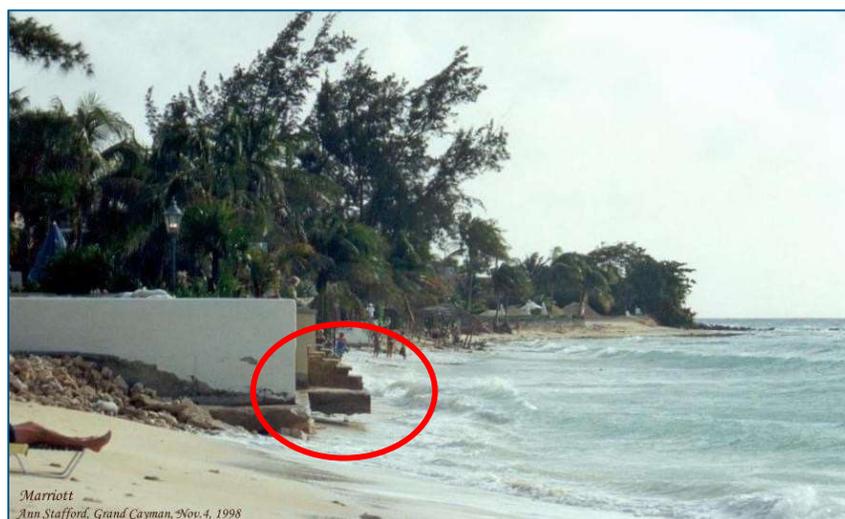
The shoreline along SMB has always been dynamic and quickly responding to changing Meteorological conditions. Figure 3-1 shows the beach in front of the Marriott hotel in 1998. The picture shows relatively high waves coming from a southerly direction. The beach is clearly eroding as can be derived from the exposed foundation of the stairs in the center left part of the picture.

Figure 3-1 Beach in front of the Marriot hotel, 1998

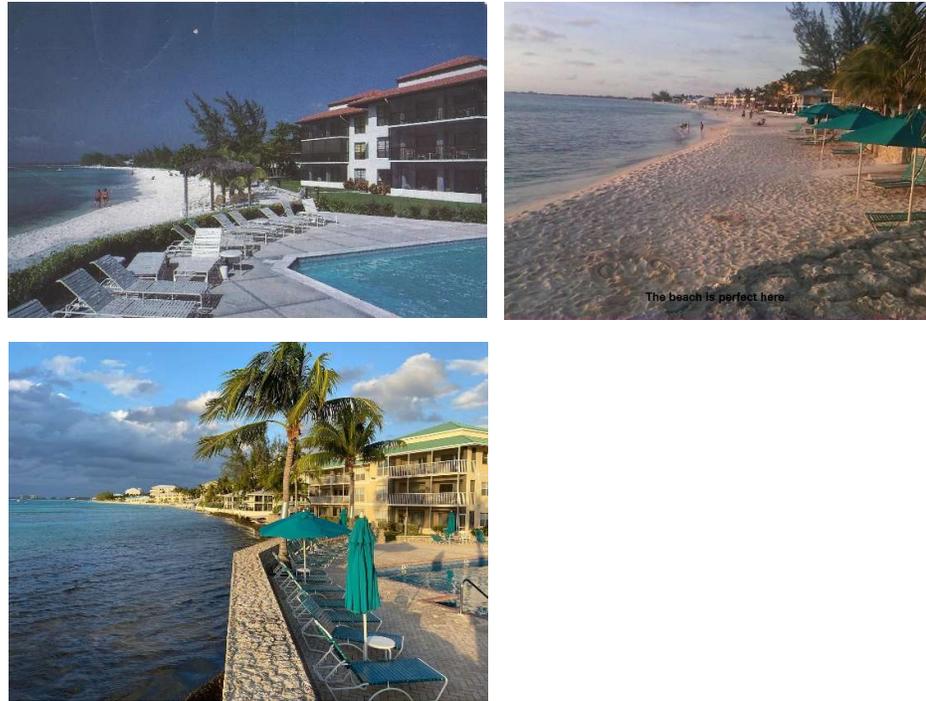
Field observations suggest that the beach width along SMB has reduced over the past years, especially in the southern part. As a result, the beach is losing its capacity to absorb the shoreline fluctuations during storms. In several locations along SMB chronic beach erosion can be observed. An example is shown in Figure 3-2 that shows the beach at Plantation village in the southern part of SMB. The pictures show the situations in 1985, 2013 and 2019. Between 2013 and 2019 the beach appears to have been lost completely.

Figure 3-2 Plantation Village looking northwards. Upper Left 1985, upper right: 2013, lower picture: 2019

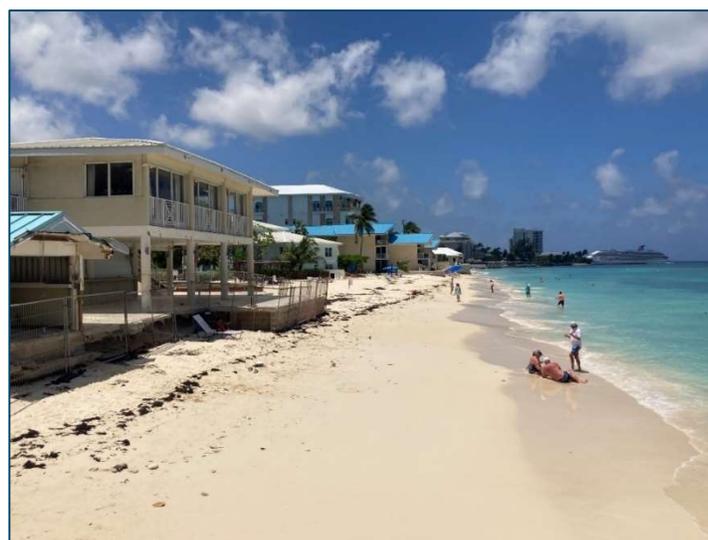
Figure 3-5 Beach in front of Royal Palms, looking southwards, 2023.

The beach in front of the Royal Palms hotel is shown in Figure 3-3, Figure 3-4, and Figure 3-5. The photos show a wide and healthy beach back in 1973. The present situation (Figure 3-5) shows a narrow beach with highwater marks very close to the wall protecting the property.

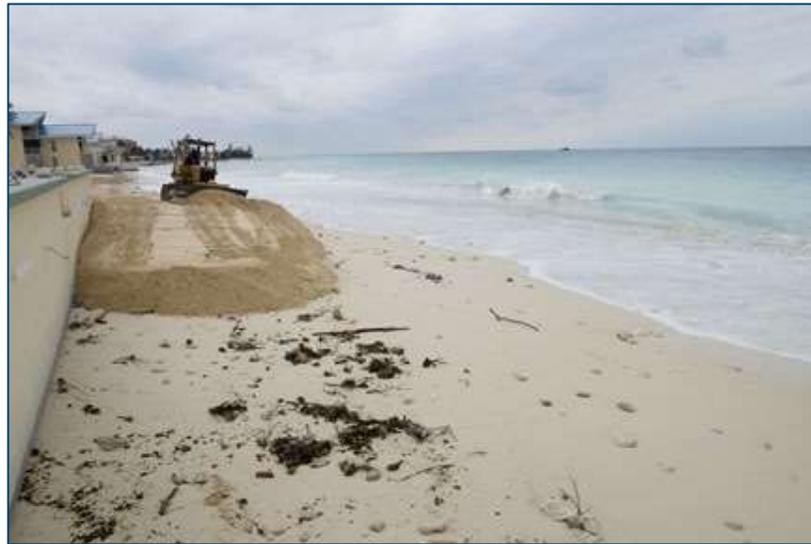
In some locations artificial beach nourishment has been applied to increase the width of the beach in front of a property, see Figure 3-6. These interventions are beneficial for the property that they aim to protect and do not have a negative impact on the adjacent beach. However, from a larger shoreline management perspective, such interventions are small and not very sustainable in the long run as the sand is likely to get dispersed rather quickly along the shore. The volume of sand necessary to restore - and maintain, the entire shoreline along SMB is orders of magnitude larger than the sand volumes supplied at one individual property. Therefore, a coordinated and integrated approach is needed to obtain the optimal result.

Figure 3-6 Sand replenishment in front of Royal palms, looking southwards, 2005.

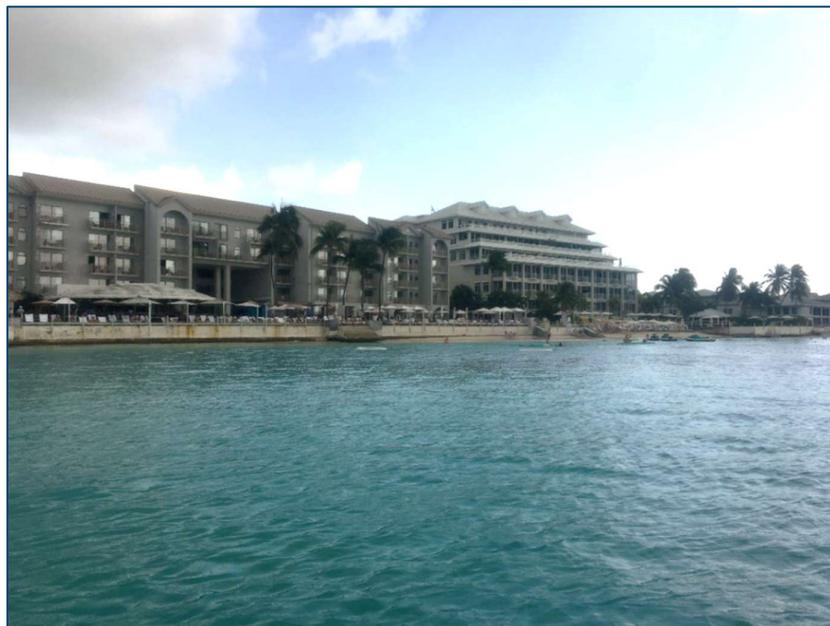
In March 2023 DHI coastal engineers visited SMB. During this visit clear signs of erosion were observed, especially along the southern side of SMB. Figure 5-1 shows the area in front of the Marriot Beach Resort in the southern part of SMB. At the day the picture was taken, the beach had disappeared completely. The seawall that supports the hotels' outer terrace was directly exposed to incident waves. It is possible that the beach would gradually restore naturally following a prolonged period of calm conditions. However, the fact that the beach has retreated so far, even without an extreme event, is worrying. If a major storm would hit when the beach is in such a poor state, then major damage could occur to building and other infrastructure close to the shoreline.

Figure 5-1 Area in front of the Marriot Beach Resort | March 2023. The beach has eroded completely. Photo: DHI

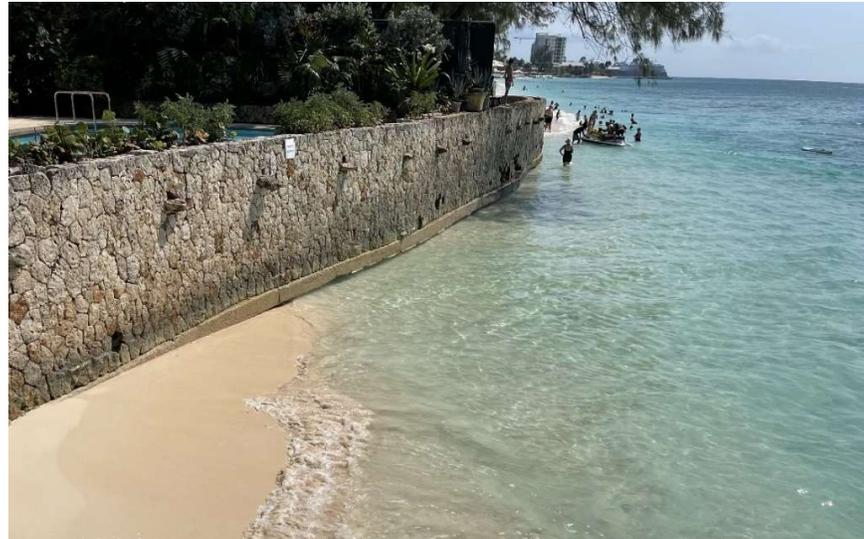
Figure 5-2 Vertical wall at the beach directly exposed to waves do increase beach erosion due to the effect of wave reflection from the wall. Photo: DHI

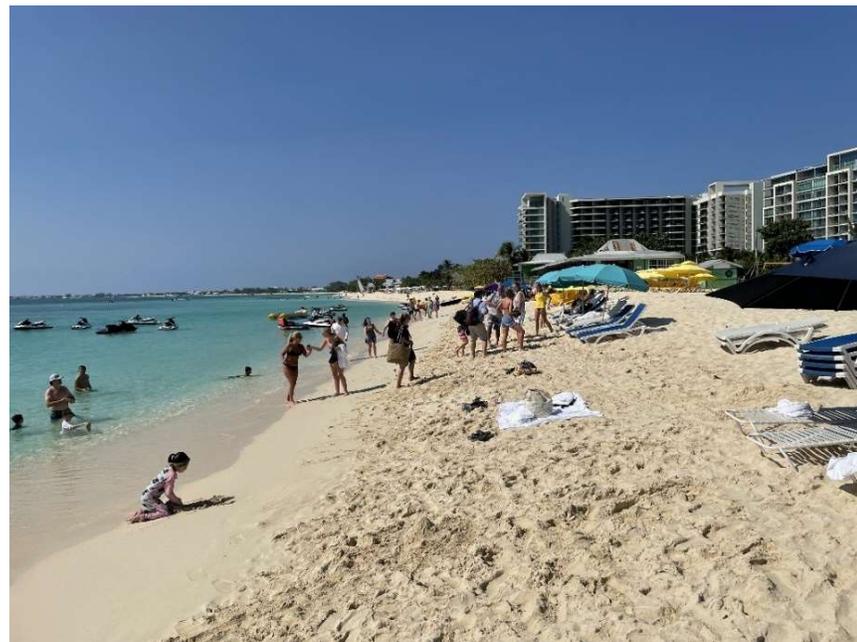
Further towards north the beaches gradually become wider and provide better conditions for leisure, see Figure 5-3.

Figure 5-3 The beach in the northern part of SMB is wider and provides better conditions for leisure. Photo: DHI

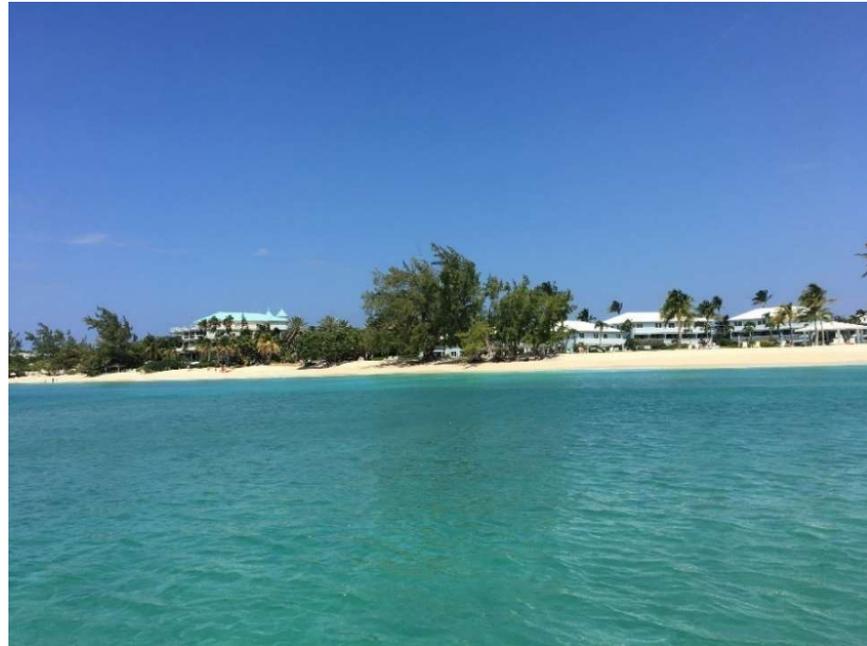
The beach along the northern end of SMB is not as heavily affected by erosion as indicated by the presence of trees and other vegetation close to the beach, see Figure 5-4. The northern limit of SMB rock exists entirely of rock with no sandy beaches, see Figure 5-5.

Figure 5-4 The beach in the northern end of SMB is less affected by erosion. Photo: DHI

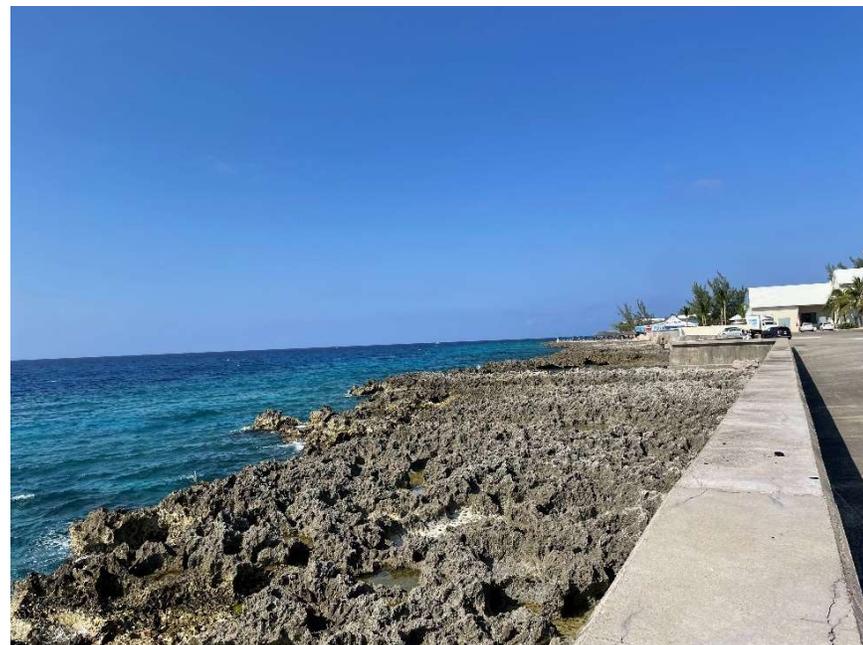
Figure 5-5 The northern limit of SMB the coast exists entirely of rock. Photo: DHI

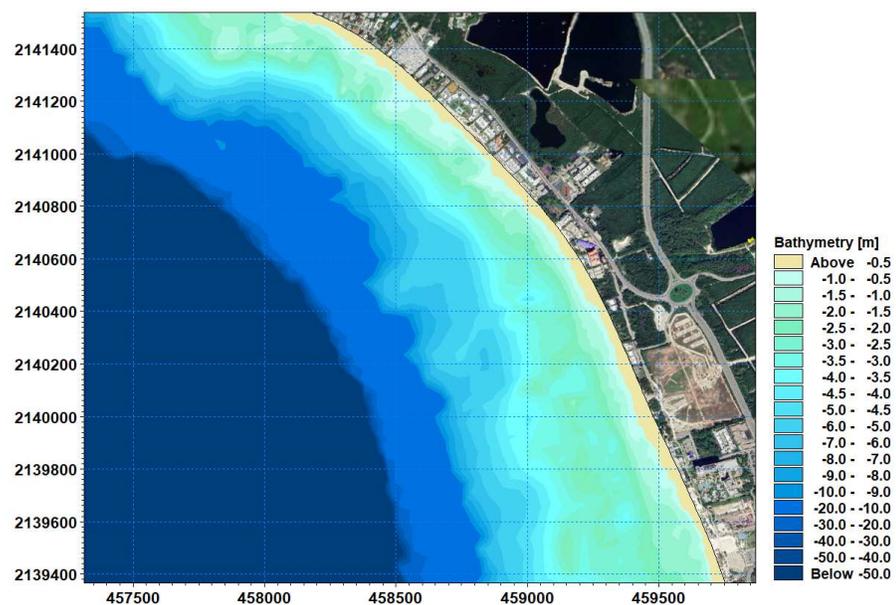
The bathymetry in the present area is characterized by shallow reef formations in front of a narrow beach of fine sand. Detailed bathymetric data was provided by DART. The data originates from a recent LIDAR survey by UKHO and provides excellent information about the nearshore bathymetry. Figure 6-1 shows a detail of the model bathymetry that was created on the basis of the provided survey data.

Figure 6-1 Detail of model bathymetry based on high resolution LIDAR data provided by DART.

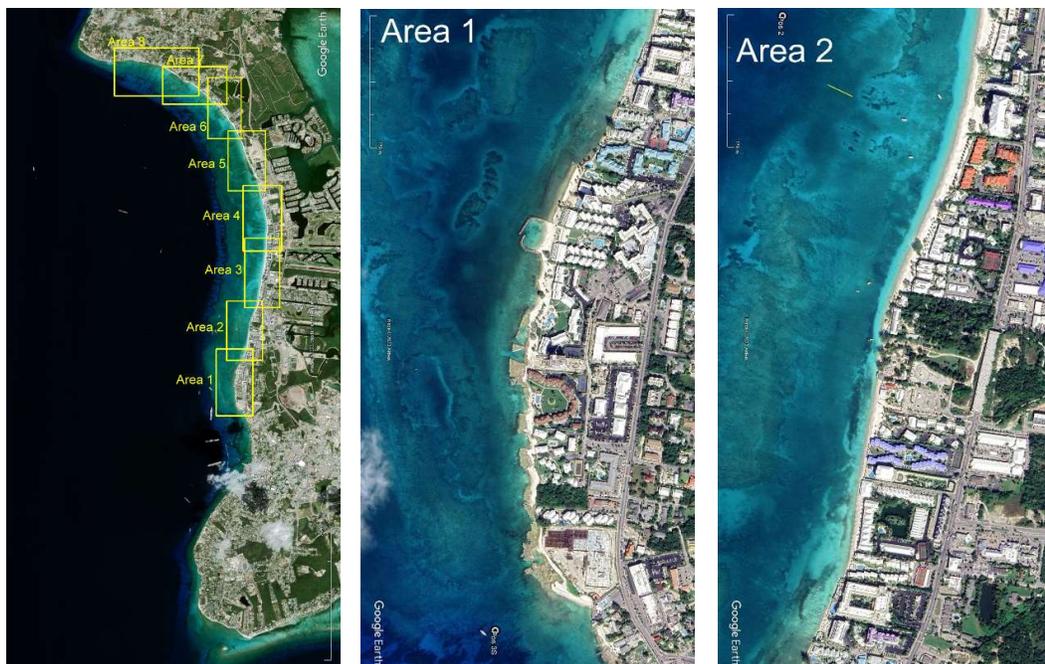
The state of the beach varies considerably along SMB. In Figure 6-2, Figure 6-3, and Figure 6-4 close ups of the shoreline along SMB are shown. In the southernmost part of SMB, the coast consists entirely of rock (Area 1). This location acts as a divergence point for the littoral current and longshore sediment transport. In the southern part of Area 1, the (potential) sediment transport current is directed towards south and in the northern part towards north. As a result, any sediment on the shoreline in this area will rapidly be washed away, either towards south or towards north. A little further towards north (Area 2) sandy beaches appear but they are quite narrow, and properties are located dangerously close to the waterline. This area is most vulnerable to damage caused by waves during storm events.

Figure 6-2 Overview of Sub areas and areas 1 and 2

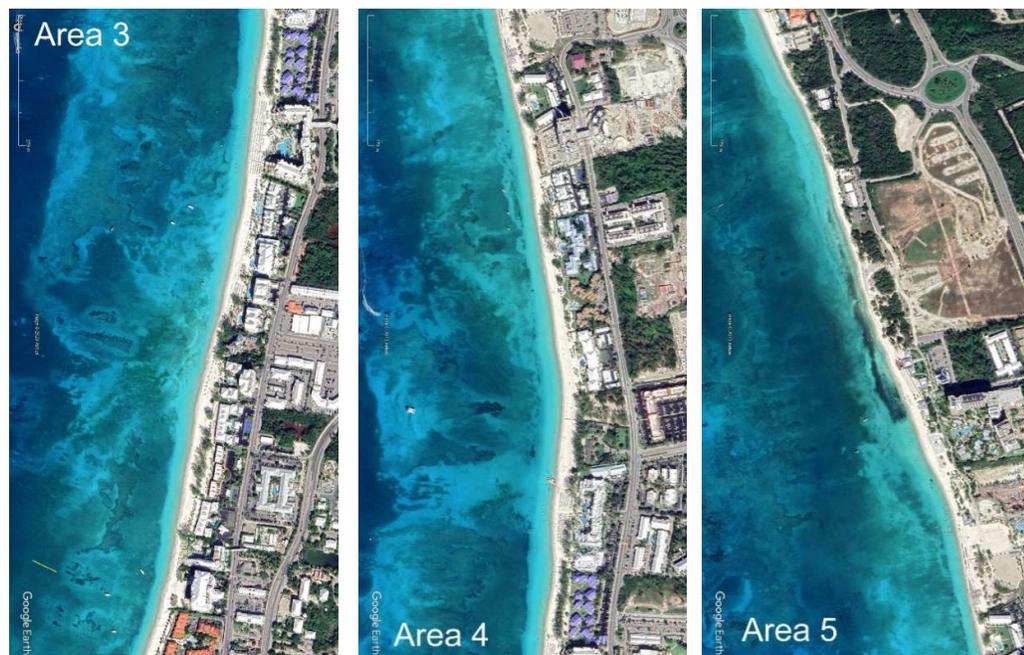
In the upper part of SMB, the beach gets narrower and in the northernmost stretch the coast consists of rock. In this part of SMB the orientation of the shoreline gets increasingly oblique compared to the prevailing wave direction. Therefore, no stable sandy beaches are found in this area. Any sand present on the shore would rapidly be transported towards south.

Figure 6-3 Sub areas 3,4 and 5

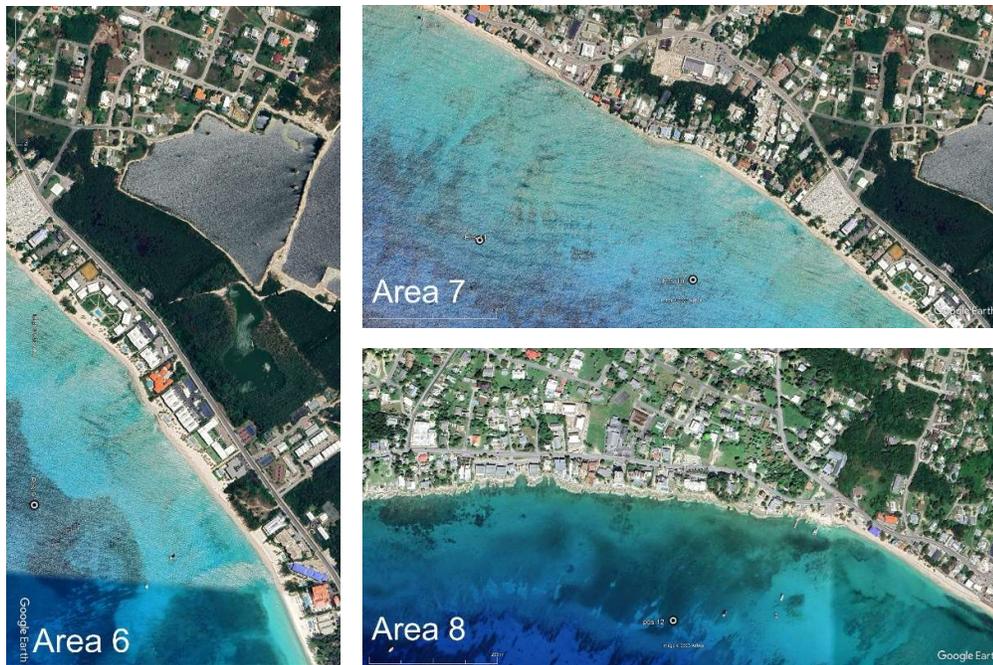
Figure 6-4 Sub areas 6,7 and 8

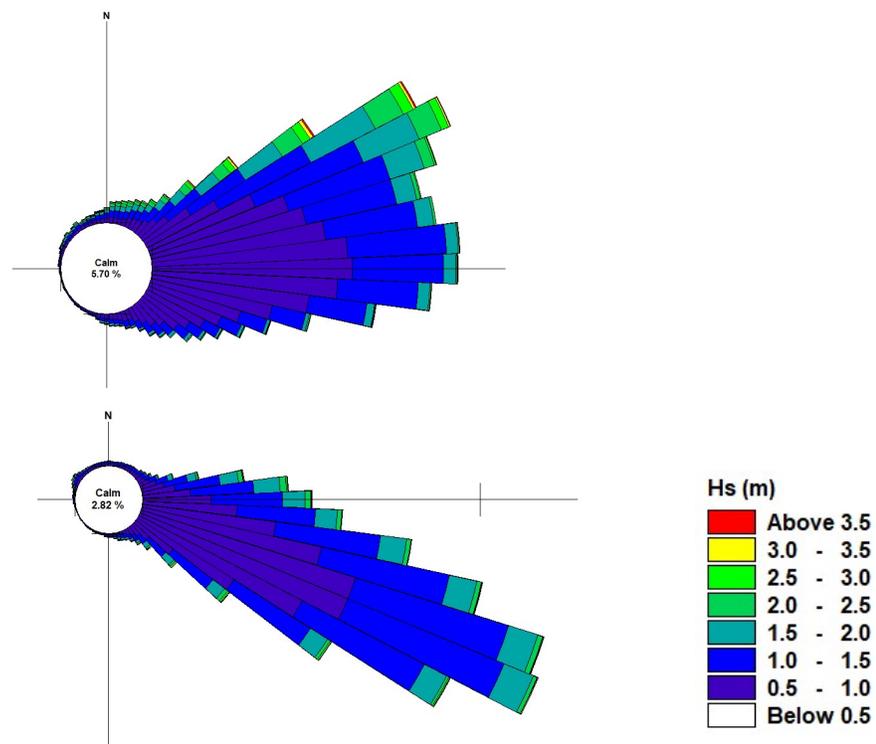
In previous studies DHI has used offshore wave data from the GROW-FINE Caribbean-2 (GFC-2) Hindcast provided by Oceanweather. More details about these data are found in DHI (2020). These data provide an excellent source of offshore wave data. However, they do not resolve the generation and propagation of tropical storms and hurricanes in great detail. The reason for this is that the size of the storms, at least in their initial phase, is small compared to the spatial resolution applied in the model. Therefore, additional model simulations were carried out, specifically focussed on hurricanes as will be described in more detail in section 9. Figure 7-1 shows the offshore wave roses north- and south of Grand Cayman. In the offshore region, waves are typically between 1m and 2m high. Waves higher than 4.0 m occur rarely. The prevailing wave direction is ENE along the northern coast of Grand Cayman and ESE along the southern coast. As a result of its geographical settings, SMB is well protected from waves from easterly directions.

Figure 7-1 Offshore wave roses derived from GFC-2 data. Upper panel: North of Grand Cayman, lower panel; South of Grand Cayman. Source: DHI (2020)

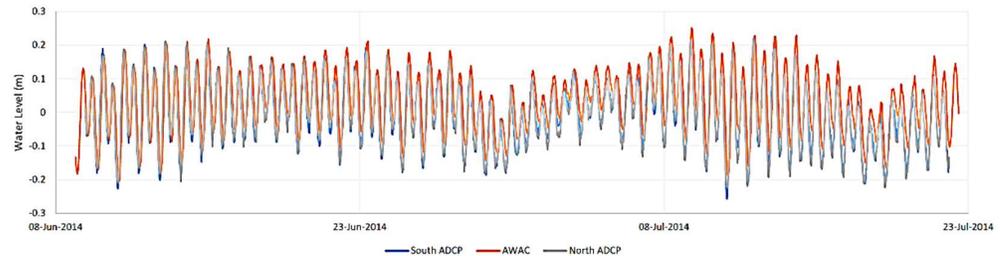
Water level variation due to astronomical tide is small with a maximal amplitude of around 0.25. During storms higher water levels are observed as a result of pressure differences and wind set-up (surge). Figure 7-2 shows a measured time series of water levels in three positions in front of SMB.

Figure 7-2 Measured water levels at SMB. Source: Baird (2015)

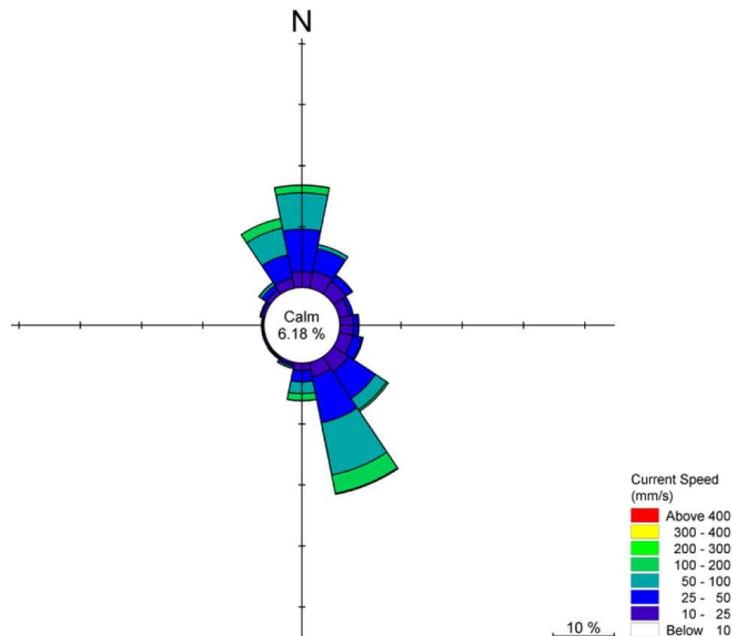
Ambient currents in front of SMB are generally weak and of no significance for the coastal sediment transport. Figure 7-3 shows a current rose based on measurements conducted in front of SMB at 15m depth. Details of the measurements can be found in Baird (2015).

Figure 7-3 Current rose based on ADCP measurements at SMB in the period June 2014 – April 2015. Water depth: 15m, source: Baird (2015)

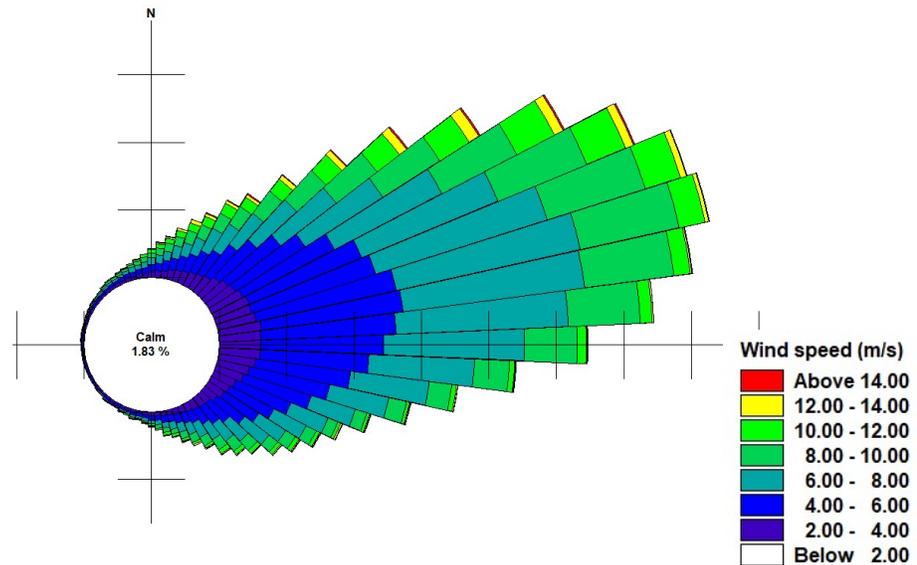
Wind data was derived from the Climate Forecast System Reanalysis (CFSR), NCEP, NOAA . The wind rose is shown in Figure 7-4. The average wind speed lies typically between 6 m/s and 8 m/s. The prevailing wind direction is ENE. It is noted that the wind data does not include hurricane data.

Figure 7-4 Offshore wind rose, source: CFSR (NOAA)

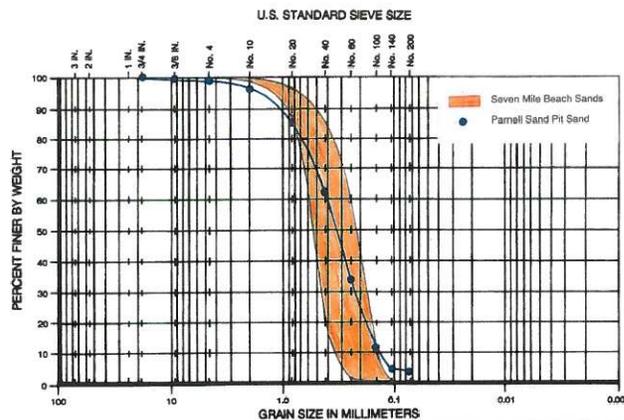
Sediments at SMB primarily consist of carbonate sand. Some variation in grain size was observed by. Grain size analyses indicate that the sediment corresponds to poorly graded sand, comprised mostly of medium sand and fine sand. The median grain diameter at the site is 0.36 mm (Figure 7-5)

Figure 7-5 Sieve curve of the sediment at the study site. Source ATM (2017).

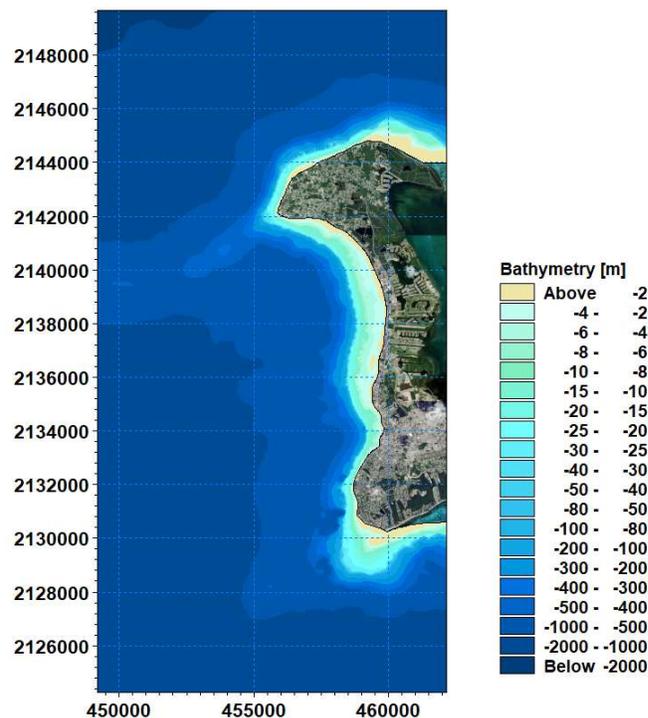
Figure 8-1 Model bathymetry applied in the simulations.

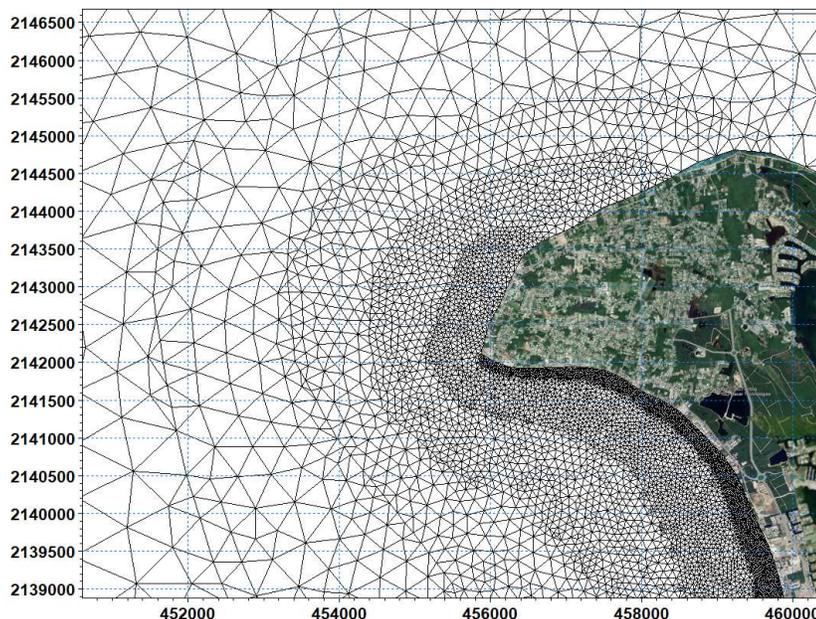
Figure 8-2 Detail of the computational grid used in the model simulations – area around the northern limit of SMB.

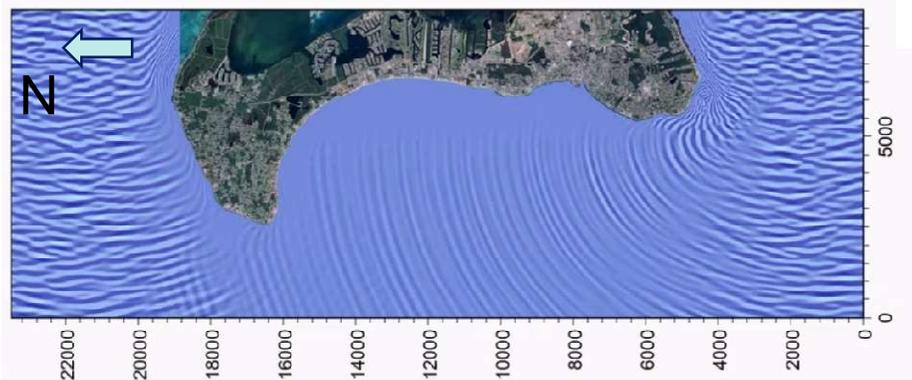
Figure 8-3 Simulated wave field under normal conditions. H_s :1.5m, T_p =8s, MWD= ESE

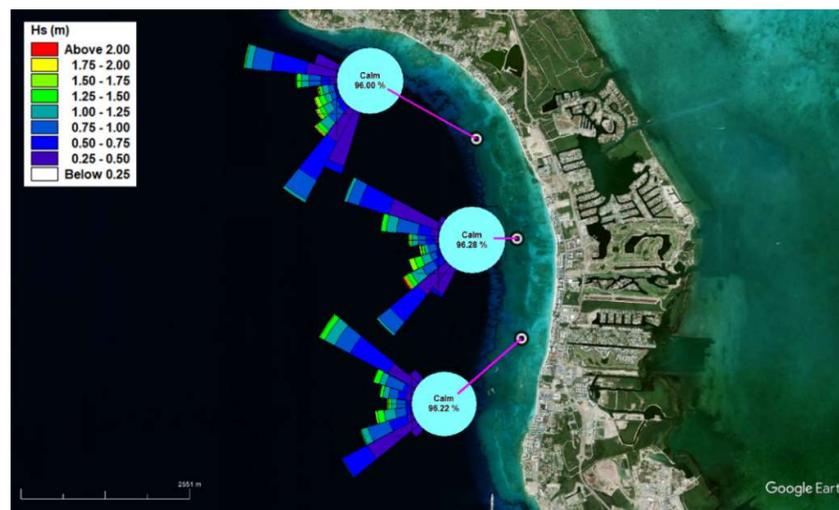
Figure 8-4 Simulated wave roses along the 5m depth contour, period : (2010-2022).

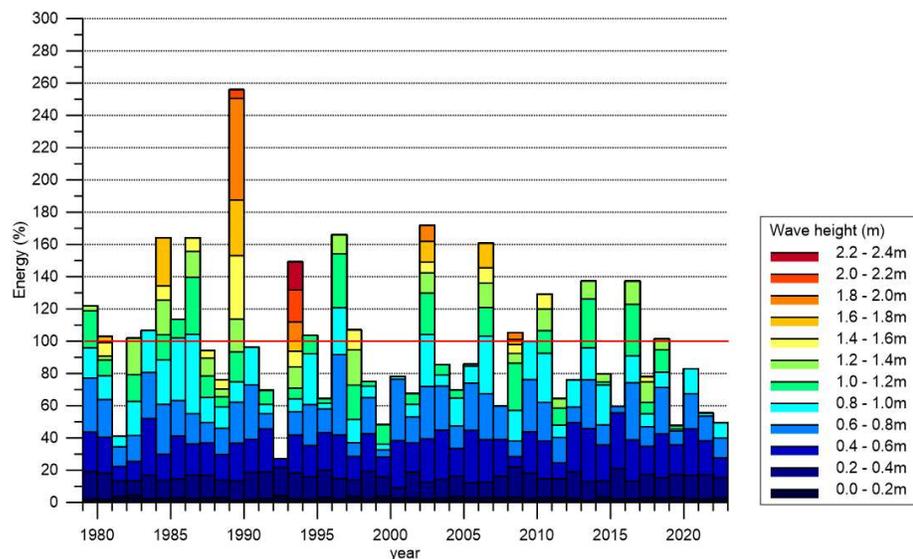
Figure 8-6 Simulated annual distribution of wave energy per wave height interval for the period 1979 – 2022 in the central part of SMB (water depth: 5m). Only offshore waves from the direction interval [NW-NNE] were considered.

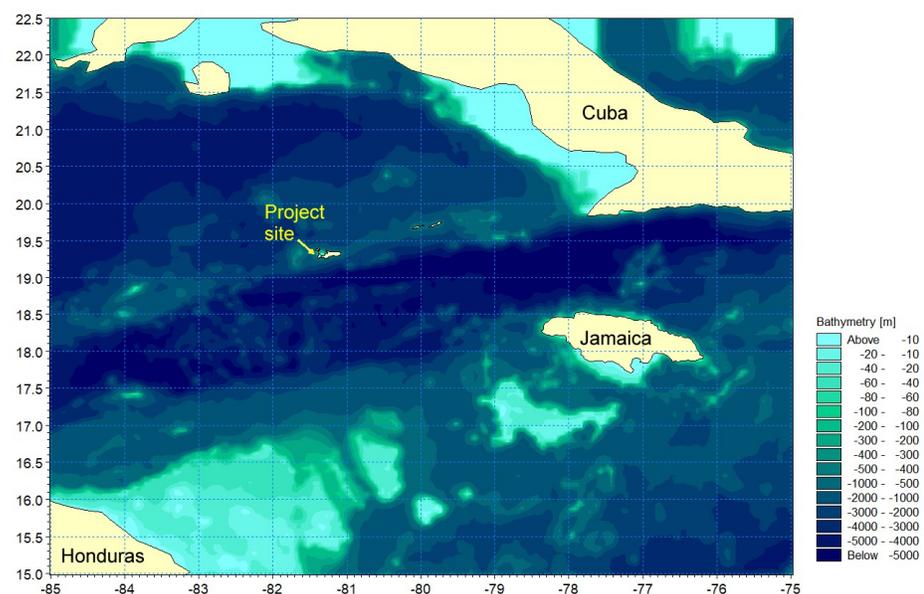
Figure 9-1 Regional-scale model for generation of wind and wave fields

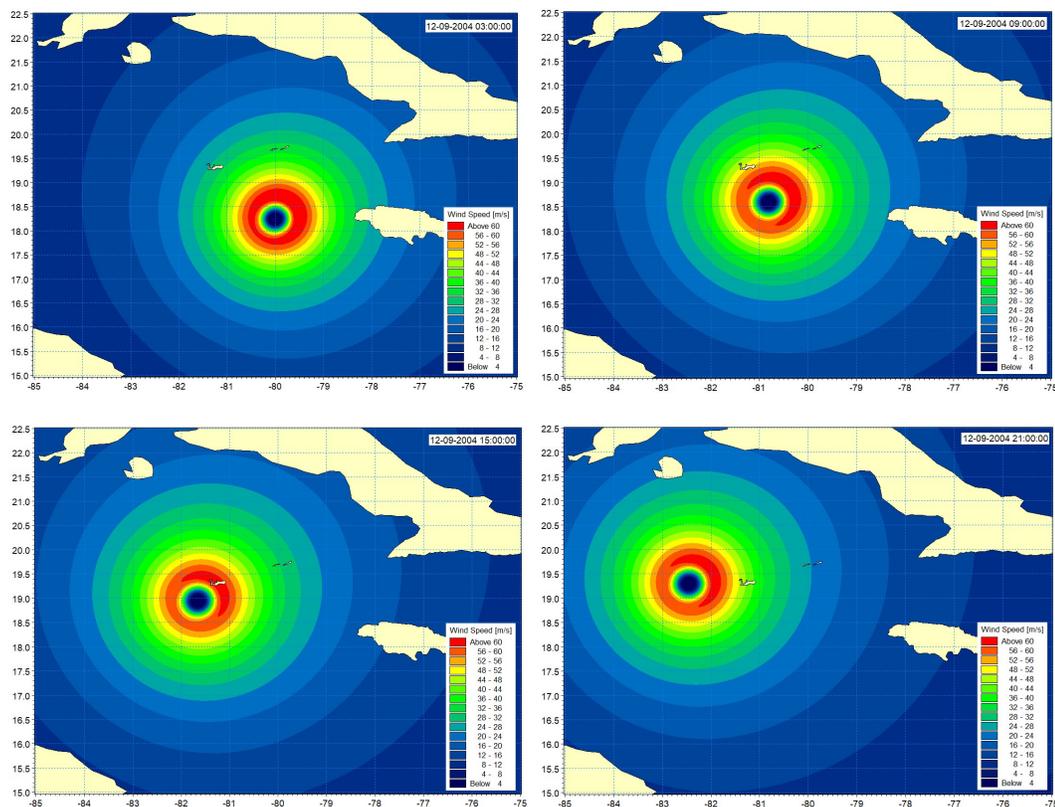
Figure 9-2 Simulated wind fields during Hurricane Ivan (2004)

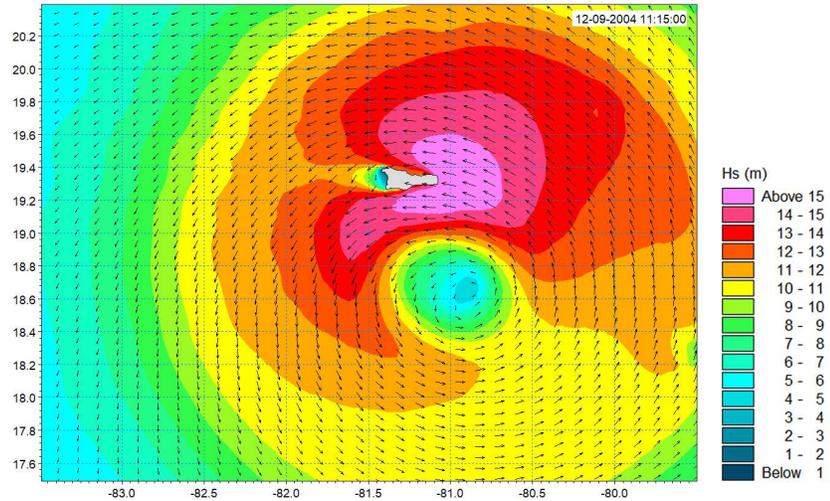
Figure 9-3 Snapshot of the simulated wave field during the peak of Hurricane Ivan (2004). The SMB is sheltered from direct wave attack.

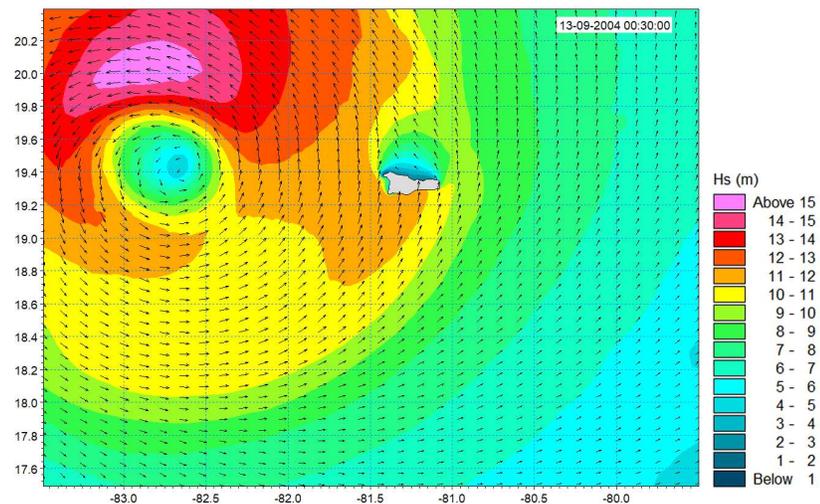
Figure 9-4 Snapshot of the simulated wave field after the passage of the eye of Hurricane Ivan (2004). The SMB is exposed to direct wave attack from west.

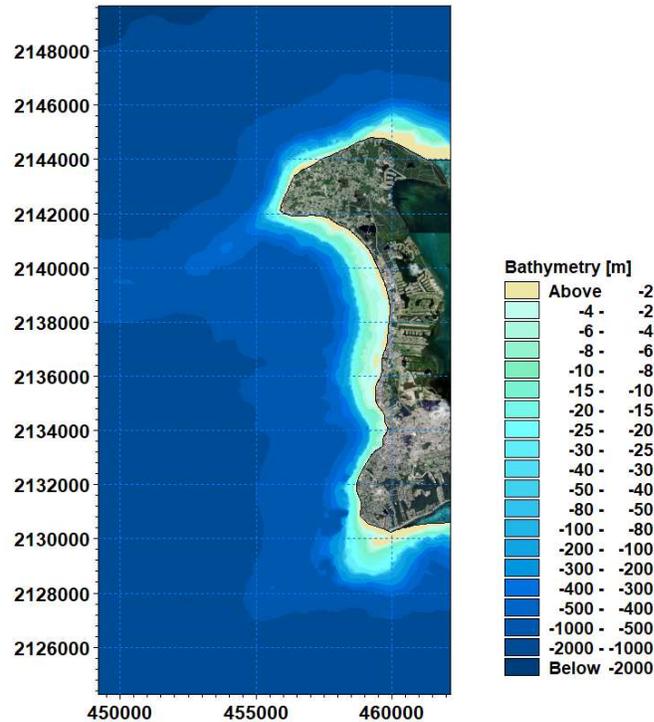
Figure 9-5 Model domain for local-scale model.

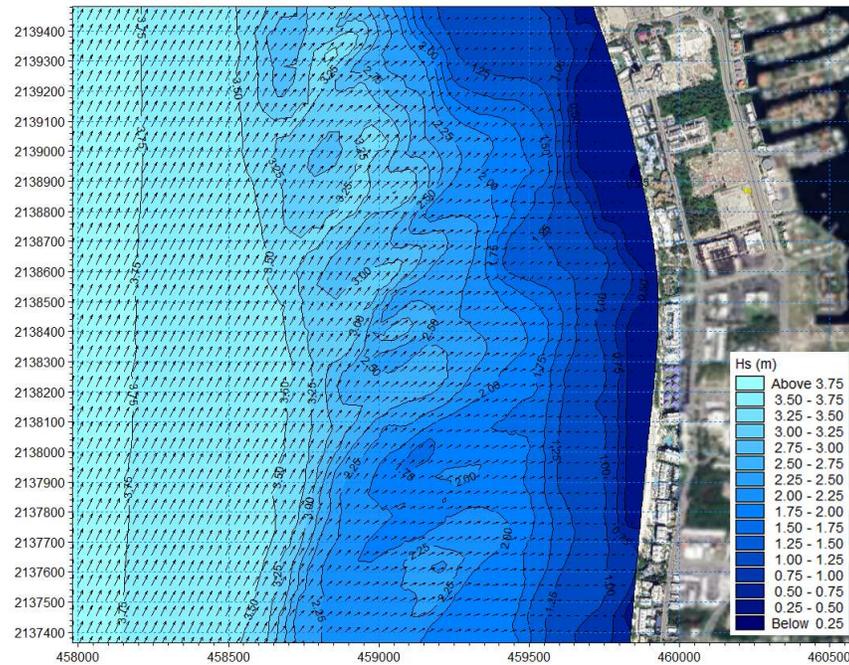
Figure 9-6 Detail of simulated wave field during Hurricane Grace (2021)

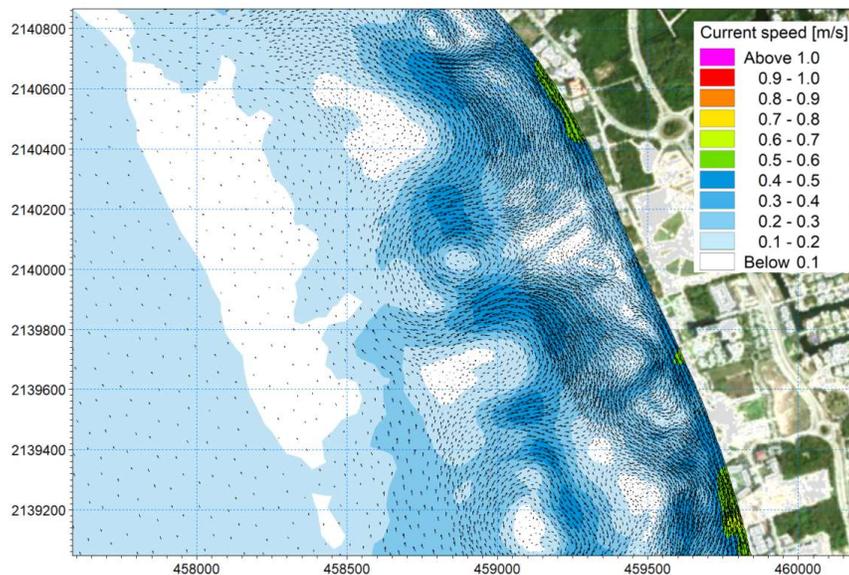
Figure 9-7 Complex wind- and wave driven flow patterns as a result of nearshore bathymetry.

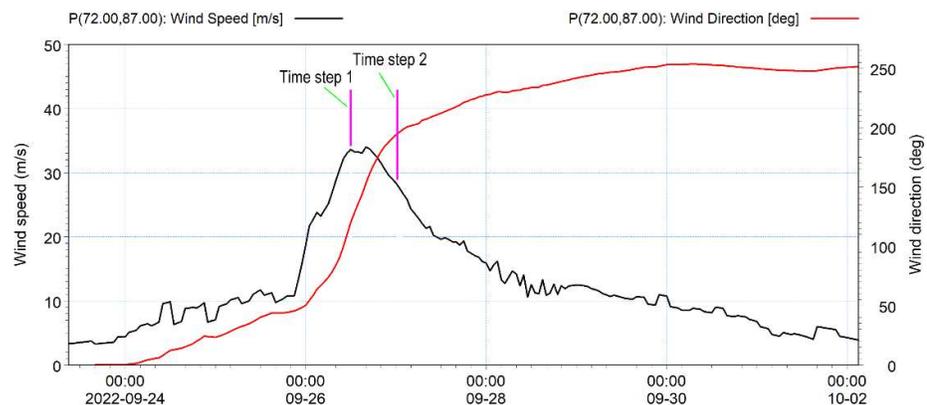
Figure 9-8 Time variation of wind speed and – direction at SMB during hurricane Ian (2022)

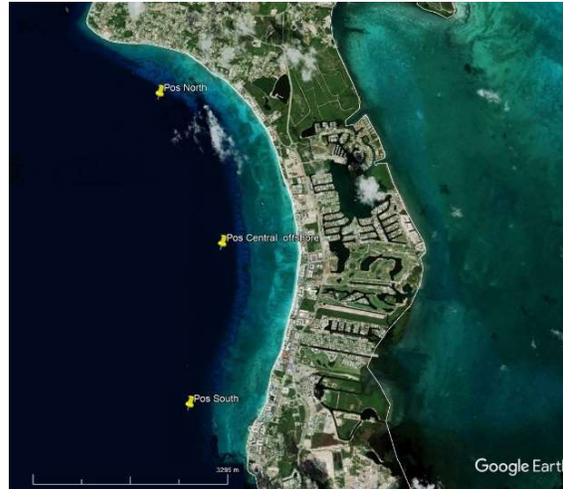
The generated wind field was used to generate waves using the 2-step approach presented above. Model results were derived in three locations along SMB, all in deep water e.g., where the waves are not affected by the seabed. The output locations are shown in Figure 9-9.

Figure 9-9 Output locations for wave parameters in front of SMB.

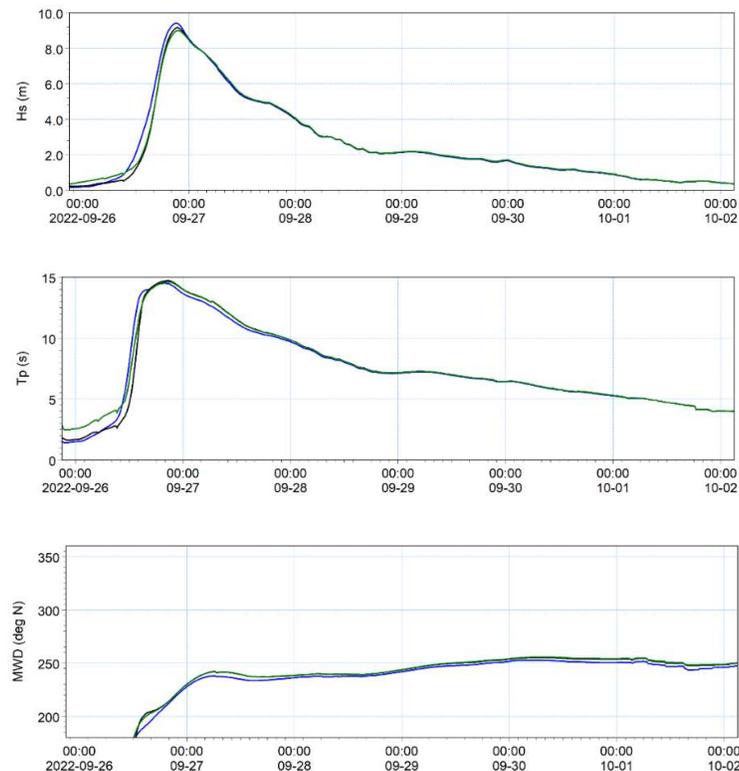
Figure 9-10 Time variation of wave parameters in from of SMB during Hurricane Ian (2022). Top: significant Wave height, middle: Peak wave period, bottom: Mean wave direction

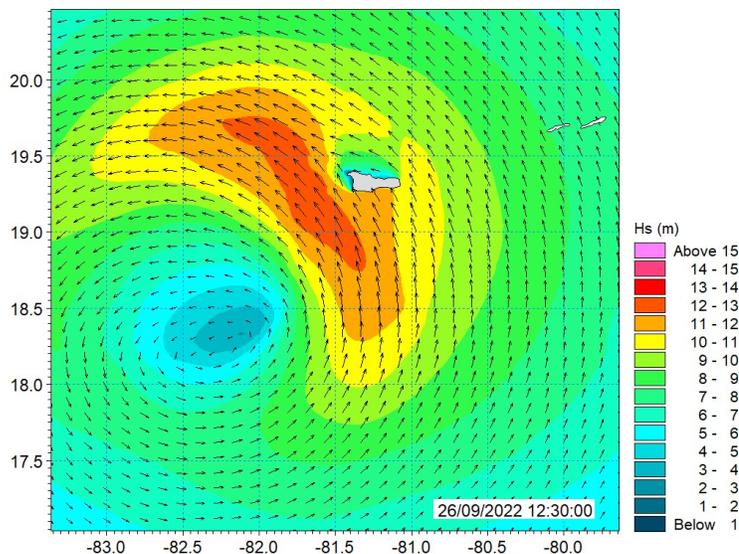
Figure 9-11 Waves during Ian (2022) – Peak of the storm, SMB is relatively sheltered for direct incident waves.

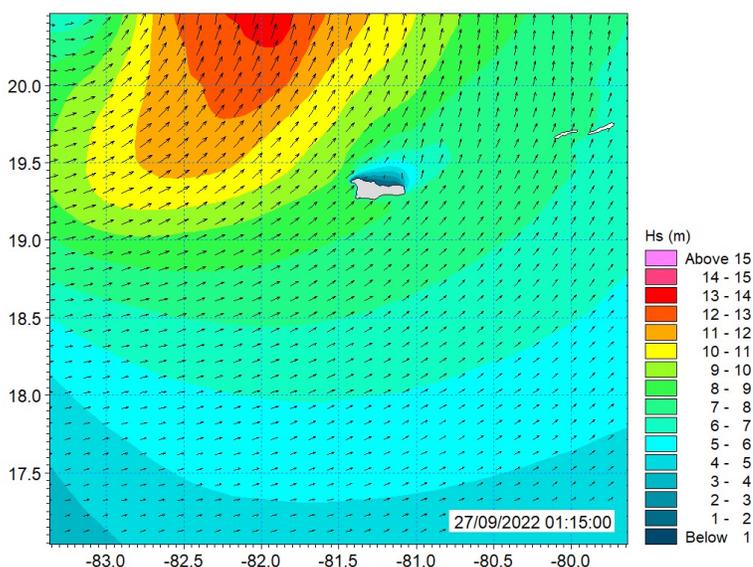
Figure 9-12 Waves during Ian (2022) – After the eye of the storm has passed Grand Cayman, SMB is fully exposed to large waves from SW.

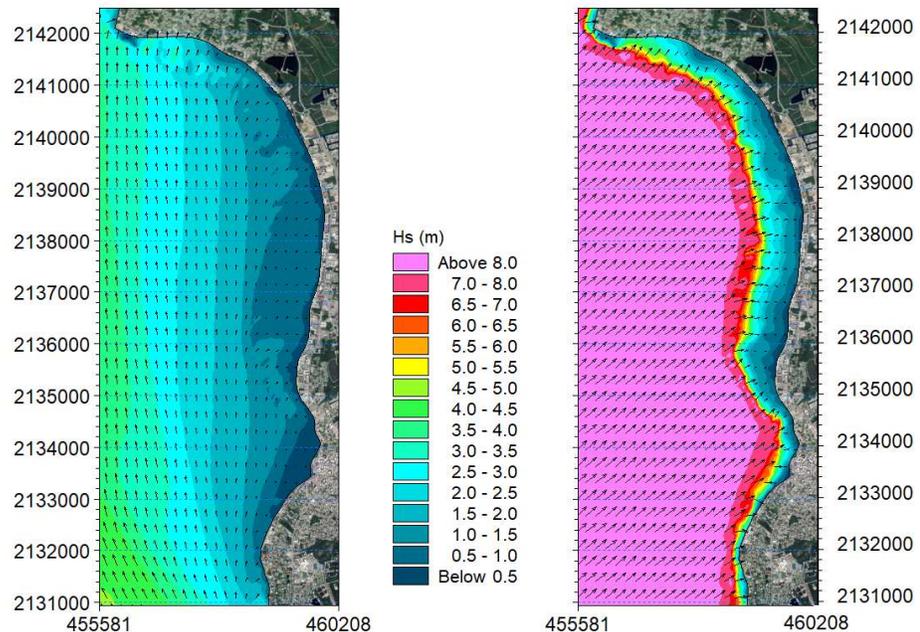
Figure 9-13 Simulated wave fields at two time steps during Hurricane Ian (2022), Left. Peak of the storm right: time step with maximal wave exposure at SMB (13 hours after the peak)

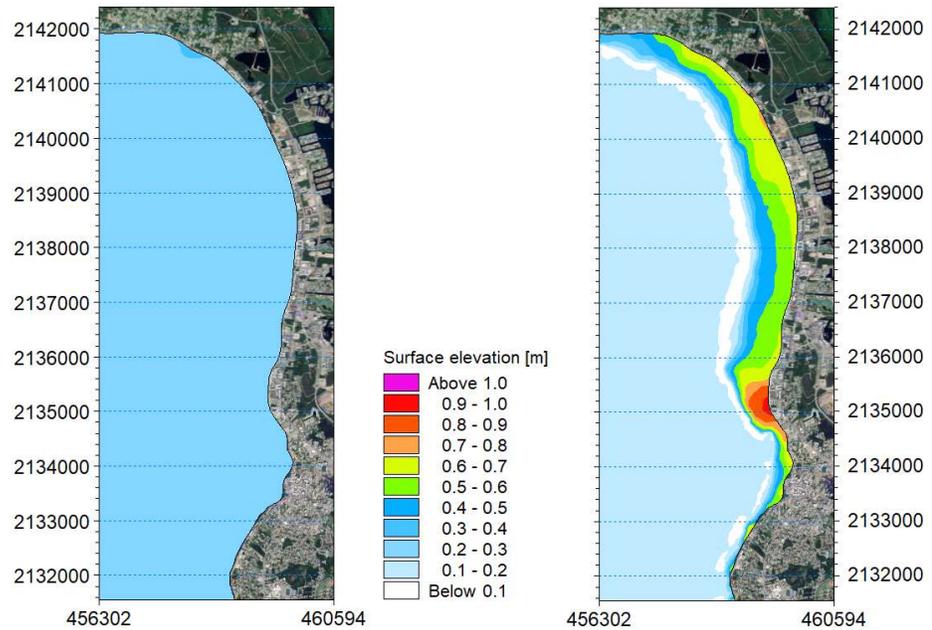
Figure 9-14 simulated water surface elevations at two time steps during Hurricane Ian (2022), Left. Peak of the storm right: time step with maximal wave exposure at SMB (13 hours after the peak)

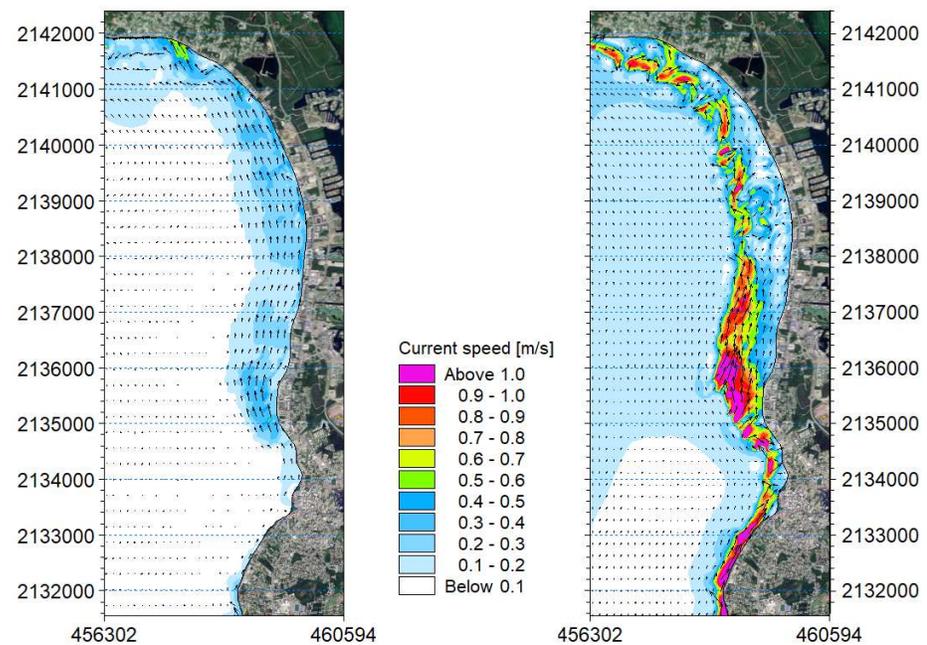
Figure 9-15 Simulated flow fields elevations at two time steps during Hurricane Ian (2022), Left. Peak of the storm right: time step with maximal wave exposure at SMB (13 hours after the peak)
