Seven Mile Beach, Grand Cayman

Beach restoration and shoreline management

Mathematical modelling studies and analyses

Draft Final Report
Project No 11829049

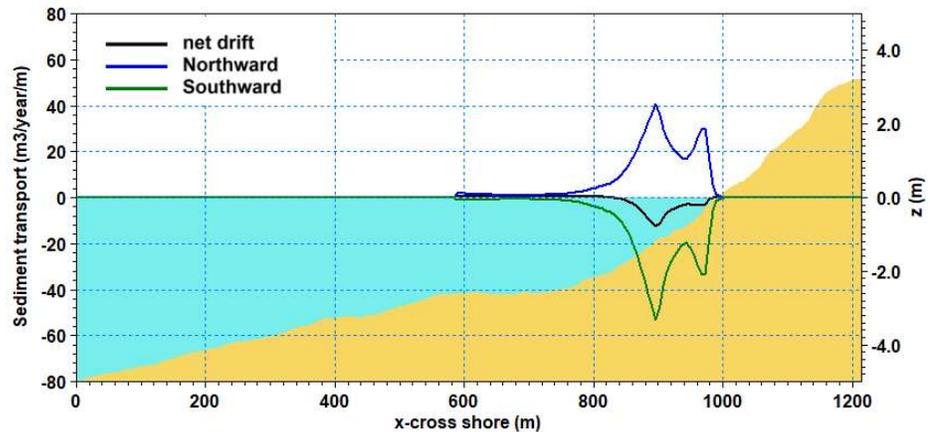
Figure 10-1 Cross-shore distribution of annual longshore sediment transport (littoral drift)

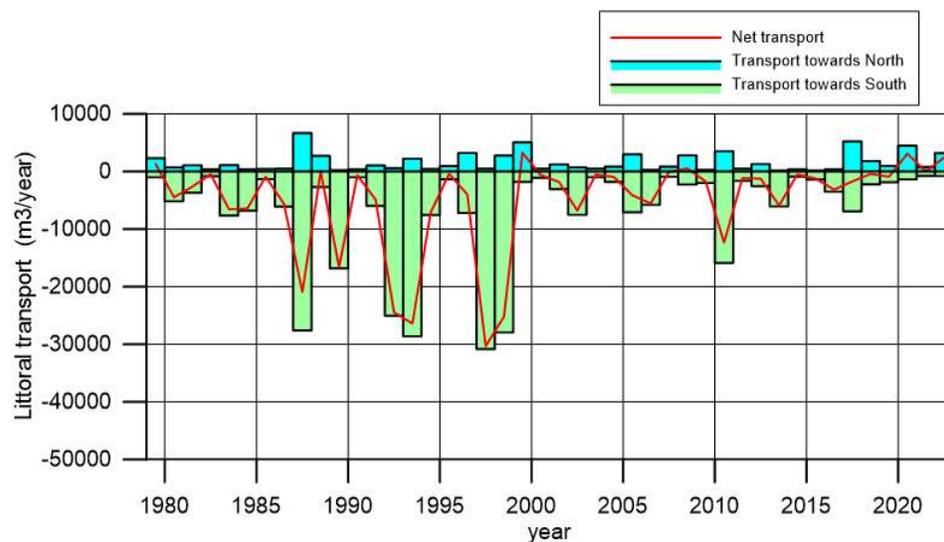
Figure 10-2 Annual variation in littoral sediment transport during the period 1979 – 2022

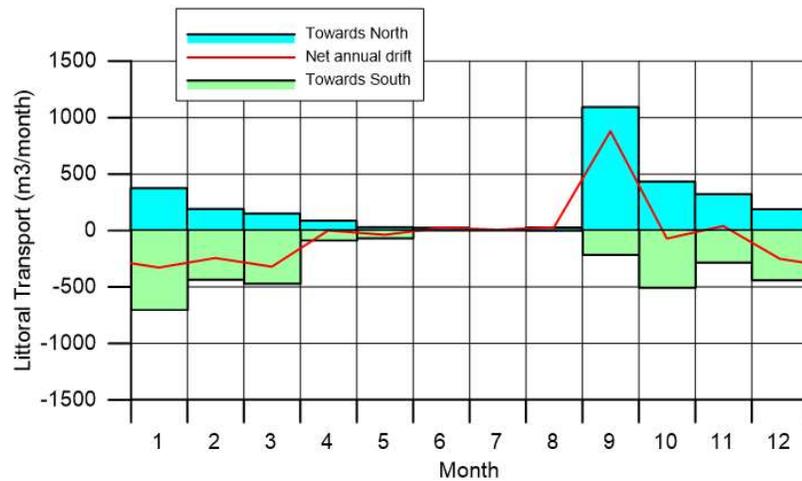
Figure 10-3 Monthly distribution of littoral sediment transport

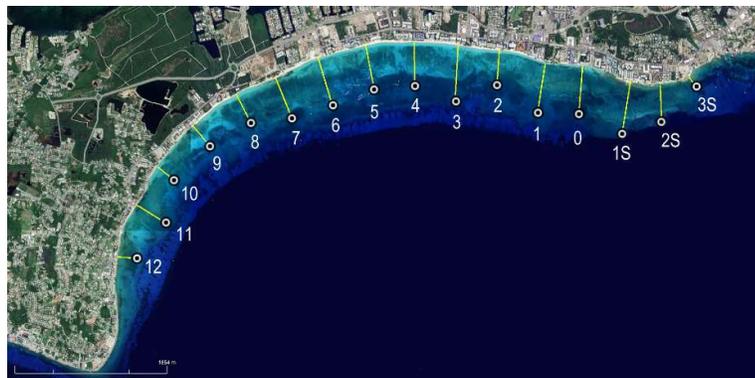
Figure 10-4 Location of cross sections used in the calculation of the annual sediment transport for normal conditions.

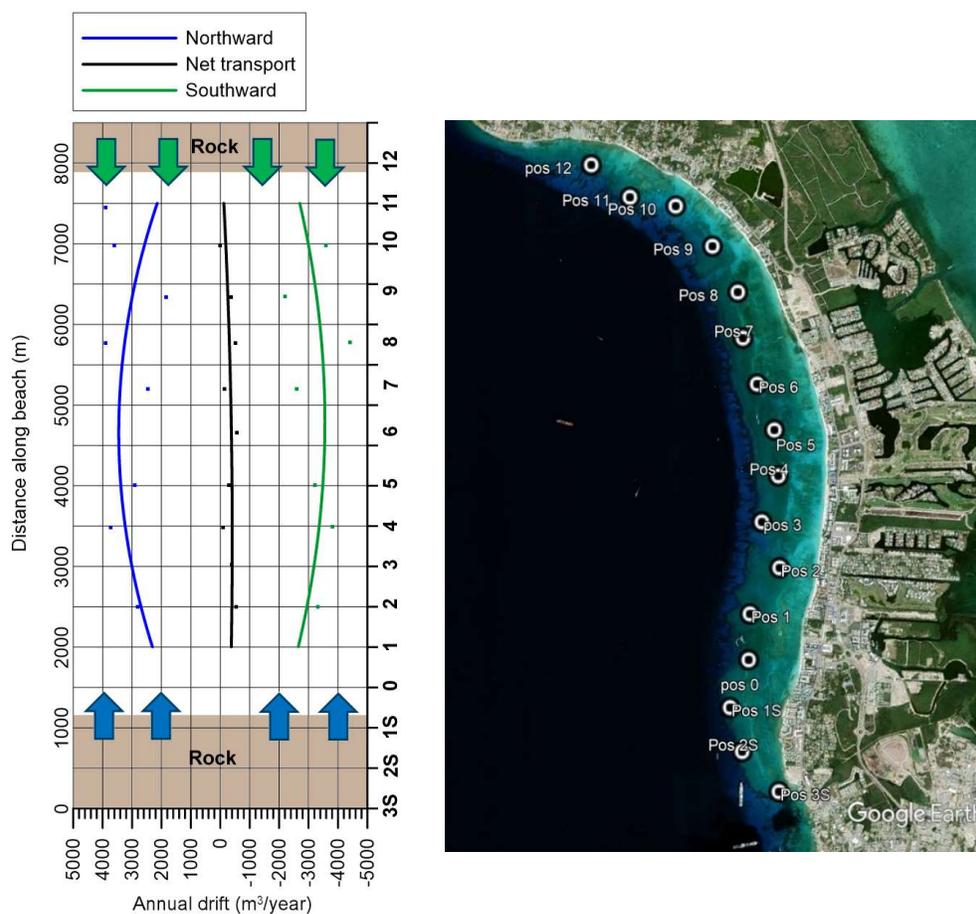
Figure 10-5 Calculated variation of net annual drift along SMB for normal conditions.

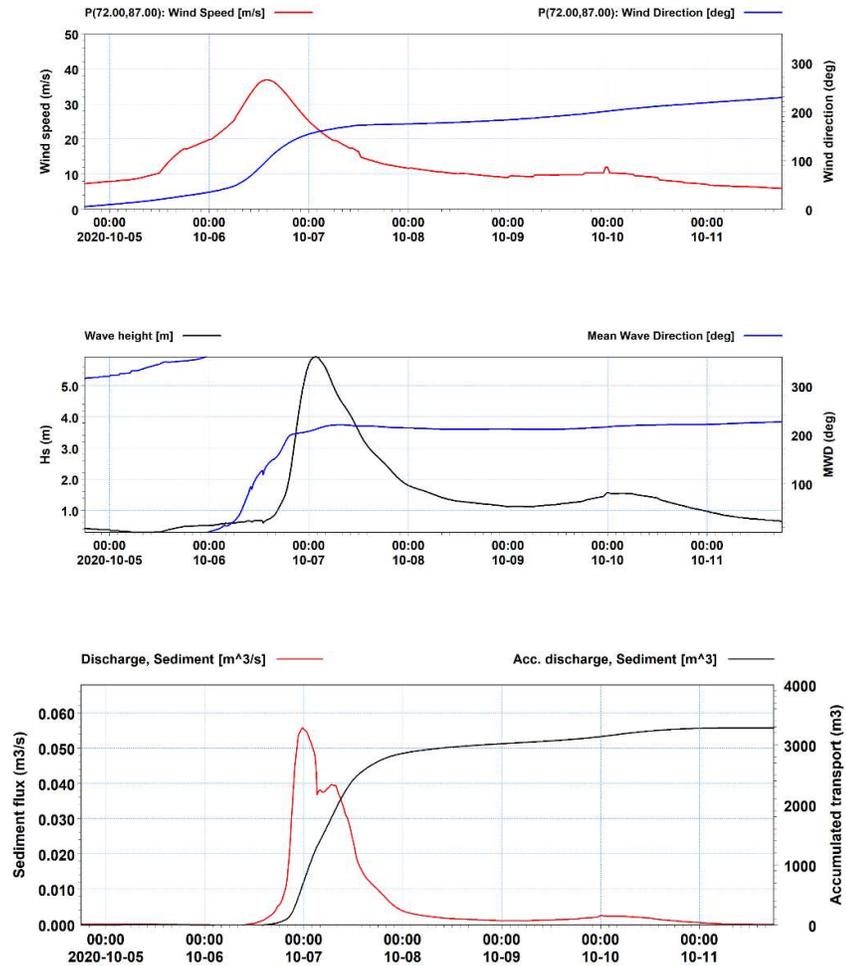
Figure 10-6 Time variation of key parameters in central part of SMB during Hurricane Delta (2020). Top: Wind speed and – direction, Middle: Wave height and – direction, Bottom: sediment flux and accumulated longshore sediment transport.

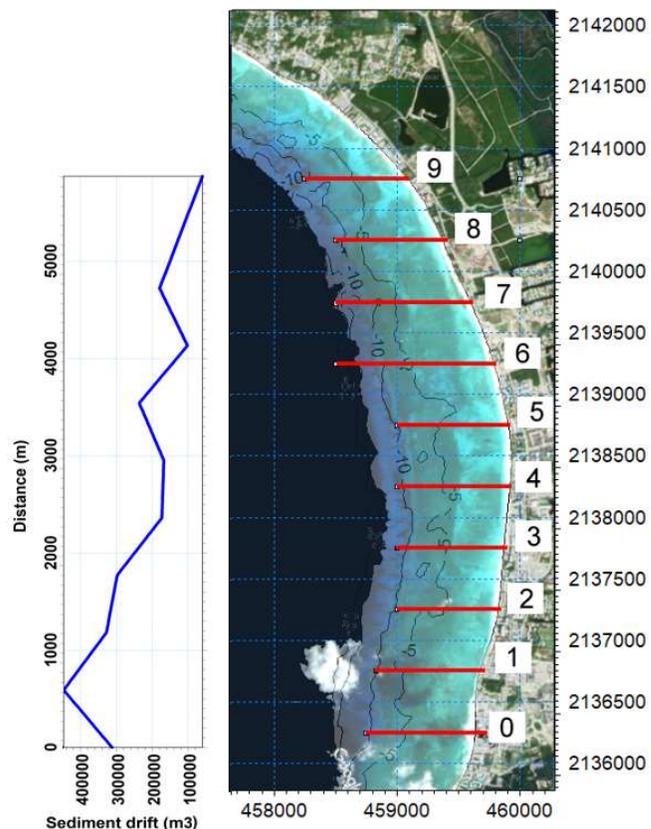
Figure 10-7 Left: Total integrated longshore sediment transport for the most important hurricanes in the period 2000-2022. Right: Positions of control sections for calculation of longshore sediment transport.

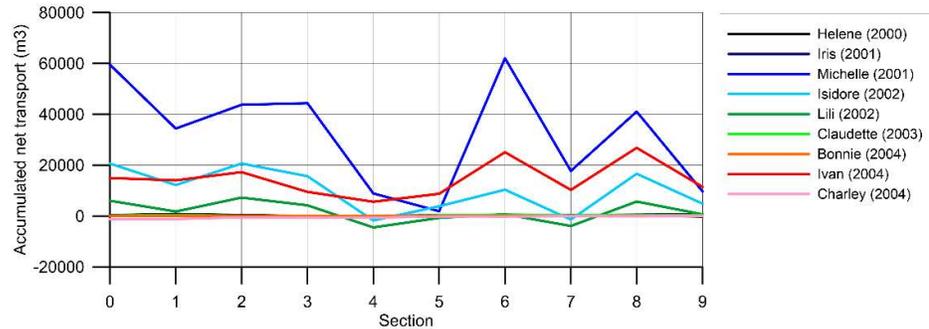
Figure 10-8 Integrated longshore transport rates during hurricanes during 2000 and 2004.

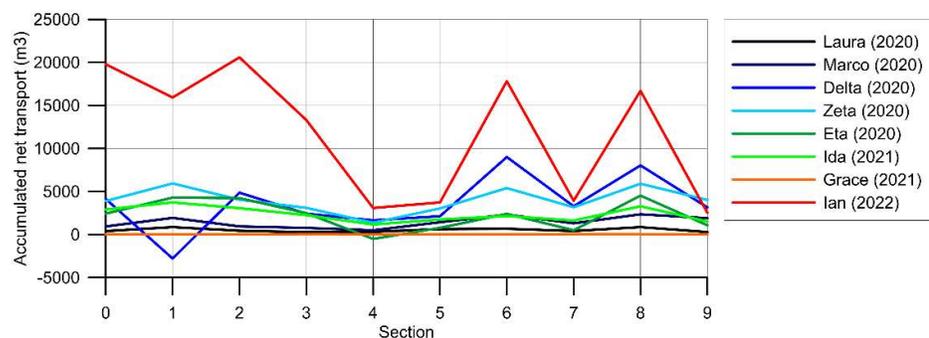
Figure 10-10 Integrated longshore transport rates during hurricanes during 2000 and 2004.

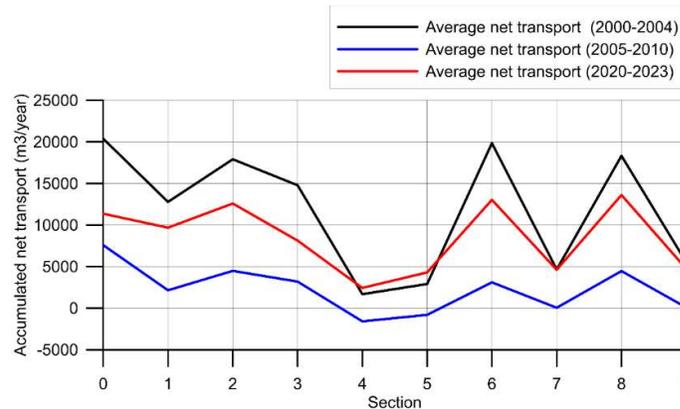
Figure 10-11 Integrated longshore transport rates during hurricanes for three different periods.

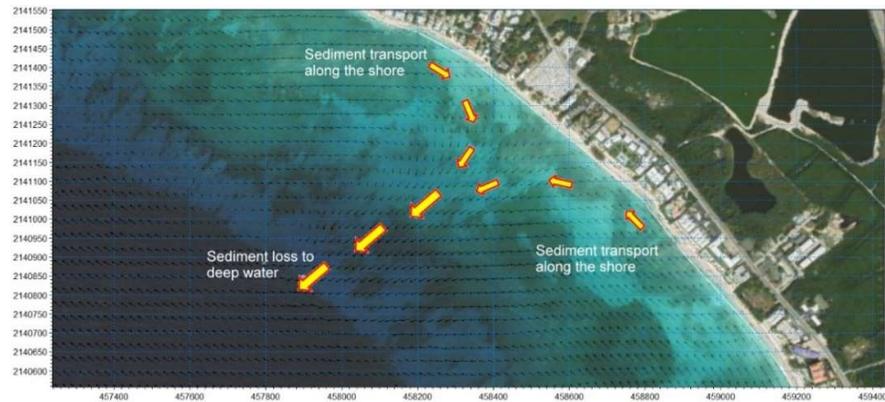
Figure 10-12 Detail of the wind- and wave generated currents in the northern part of SMB during Hurricane Ian. The vectors indicate the transport of sand from the shoreline towards the edge of the reef.

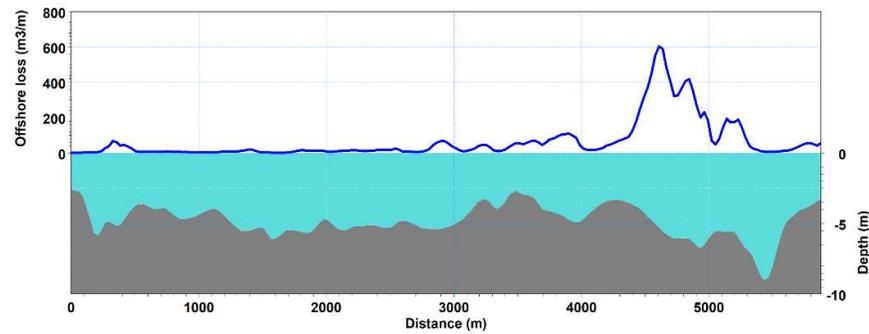
Figure 10-14 Variation of water depth and offshore directed sediment transport along a control section represented by the yellow line in Figure 10-13.

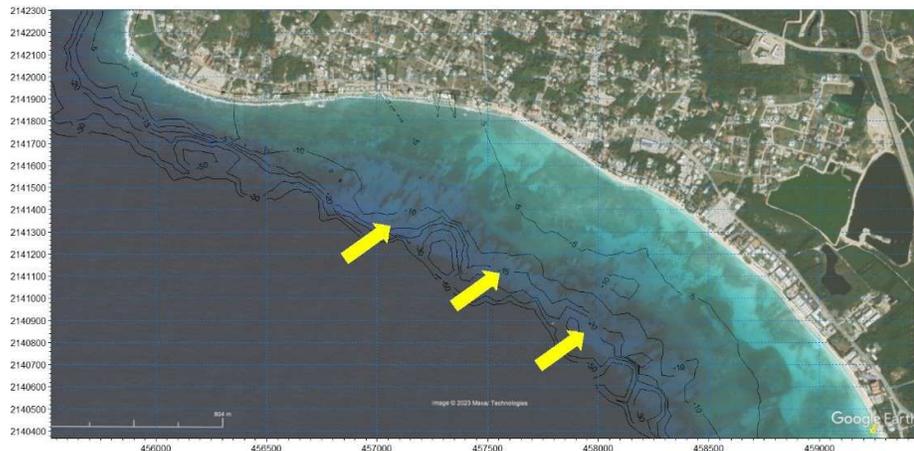
Figure 10-15 Nearshore sand accumulations northern part of SMB

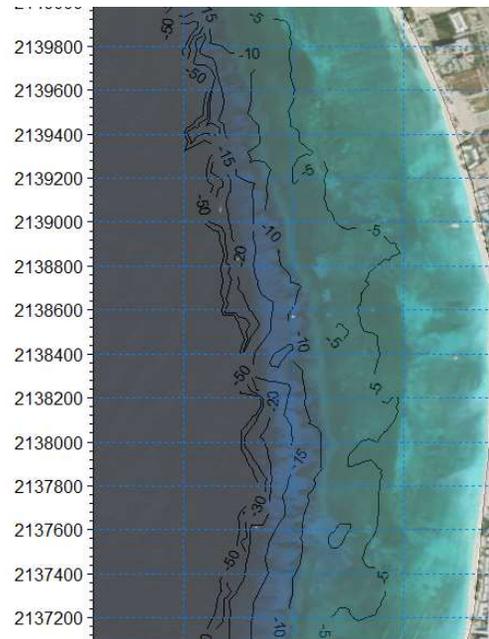
Figure 10-16 Nearshore sand accumulations central part of SMB

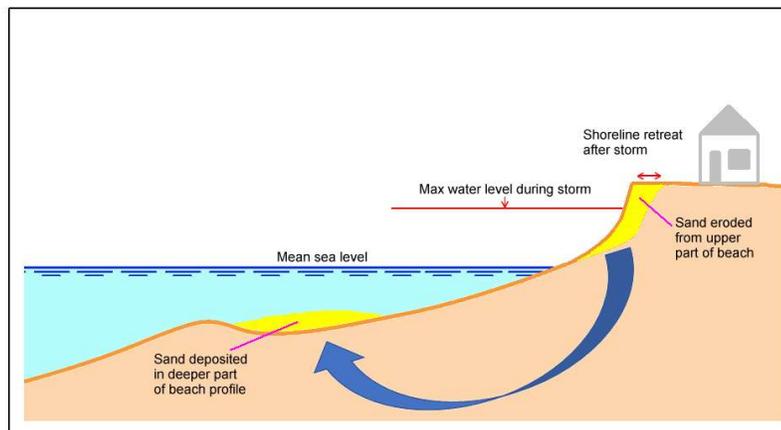
Figure 10-17 Destruction phase (storms, hurricanes): Erosion of upper part of the beach profile during periods with high water levels (surge) and high waves. Time scale: hours to days

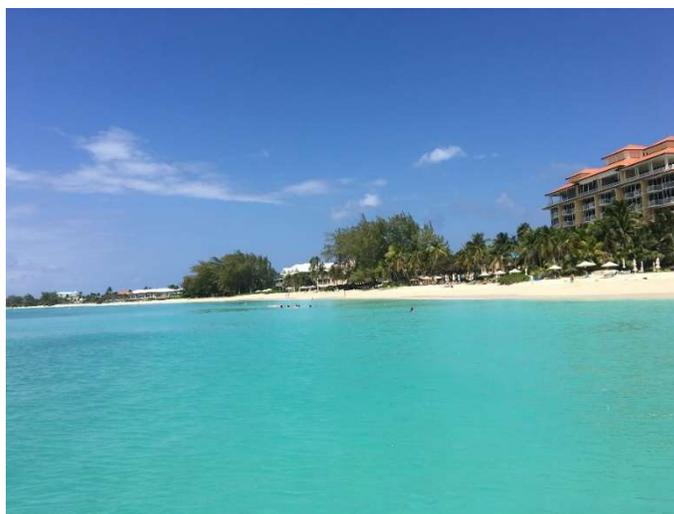
Figure 10-18 Recovery phase (calm periods): Gradual transport of sand from the shoal back to the water line. Time scale: weeks, months, years

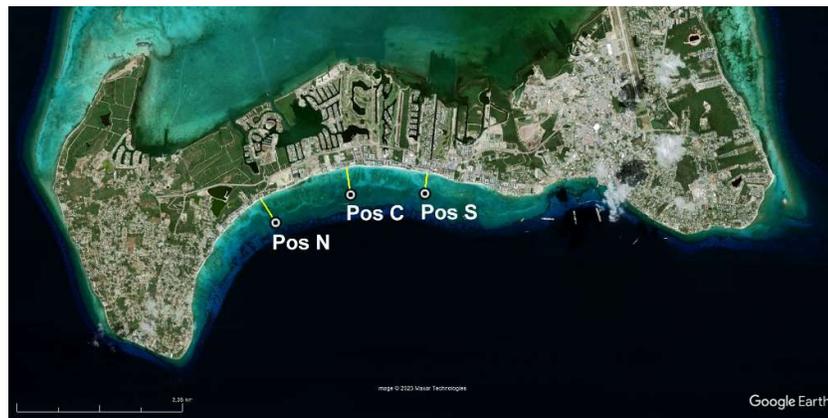
Figure 10-19 Cross sections used in the simulation of cross shore profile dynamics during storms.

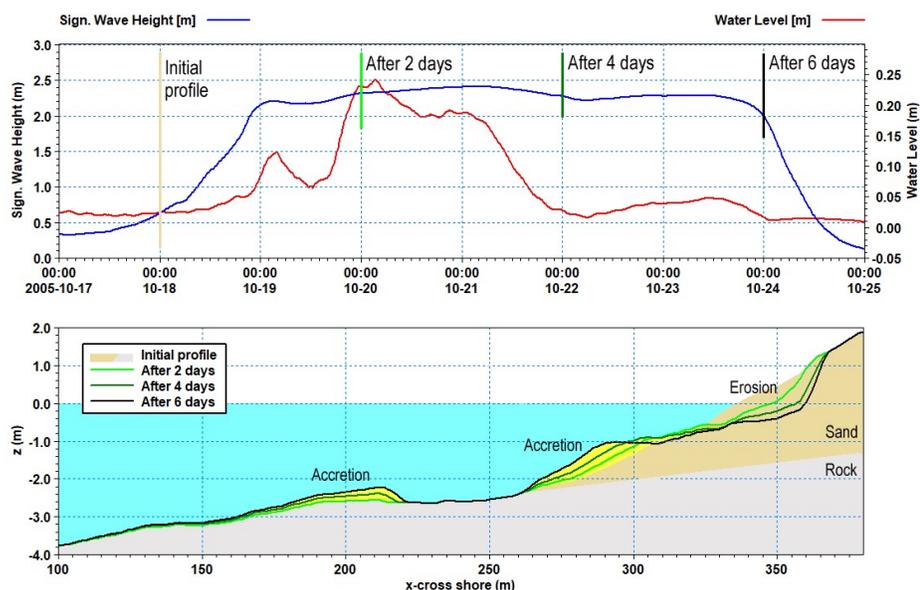
Figure 10-20 Simulated cross shore profile dynamics during hurricane Wilma (2005). Upper panel: Time variation of wave height and water at seaward boundary. Lower panel: Cross shore profile at start of simulation and after 2,4, and 6 days.

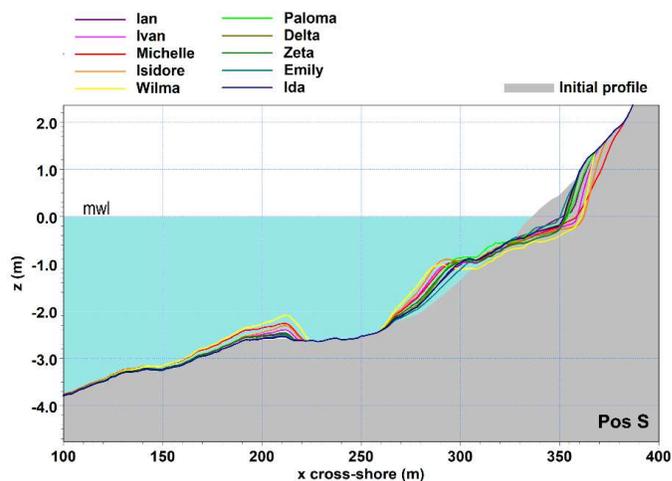
Figure 10-21 Simulated cross shore profiles during recent hurricanes Position S

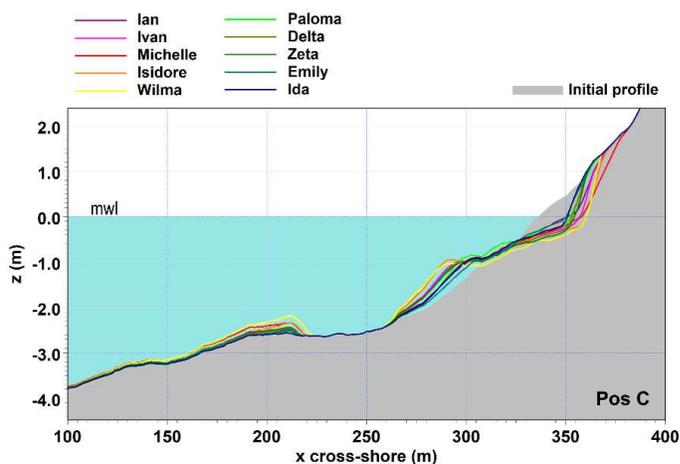
Figure 10-22 Simulated cross shore profiles during recent hurricanes Position C

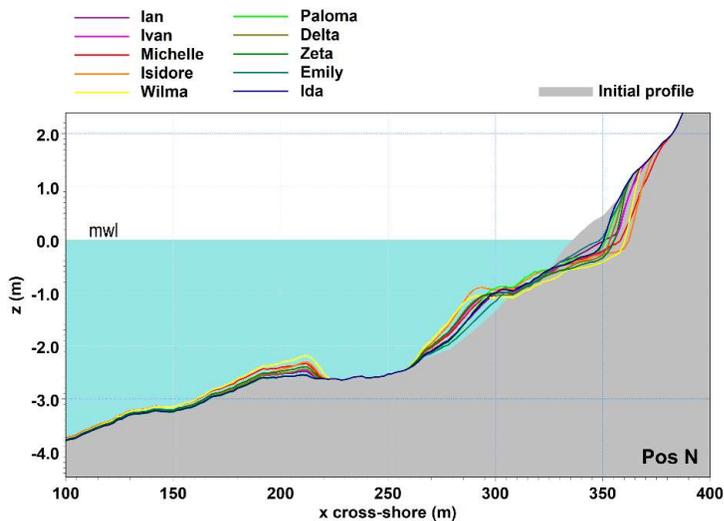
Figure 10-23 Simulated cross shore profiles during recent hurricanes Position N

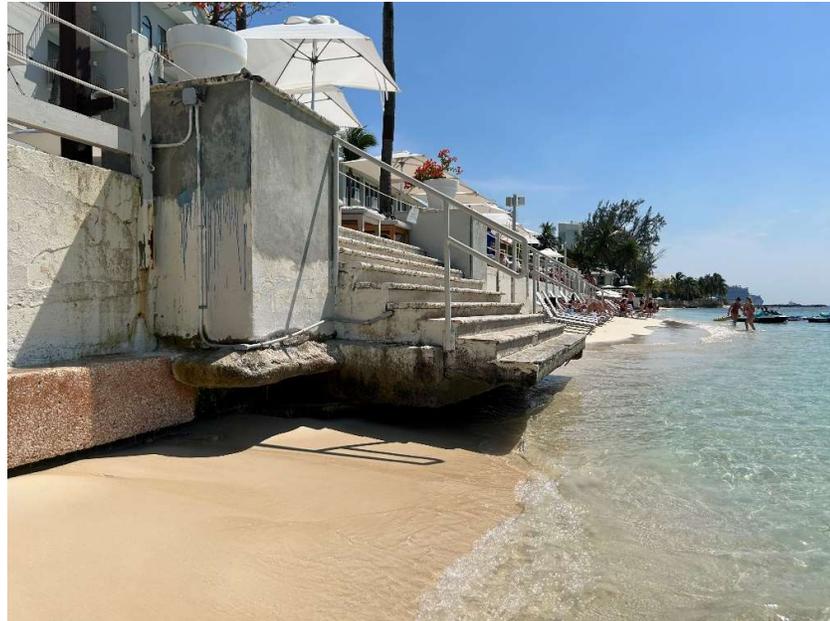
Figure 10-24 Beach erosion in front of the Marriot Beach Resort. Notice the stairs at the beach “hanging in the air”. Photo: DHI, March 2023.

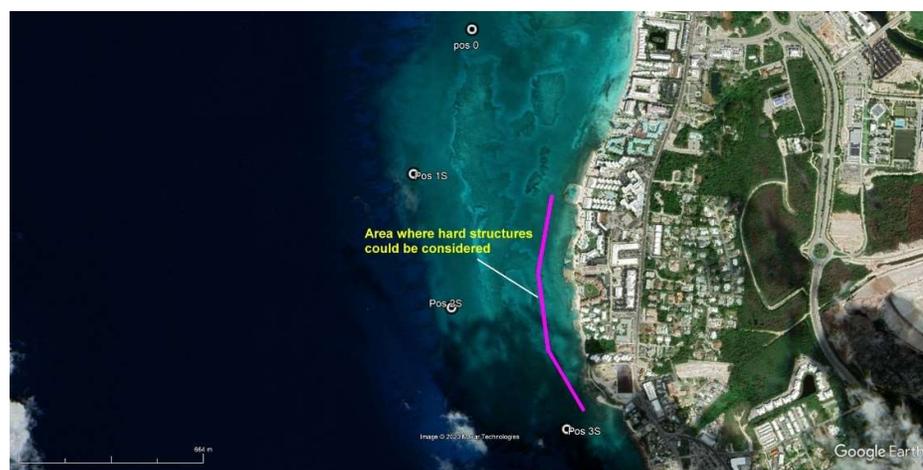
Figure 11-1 Area where hard structures could be considered – Southern part of SMB.

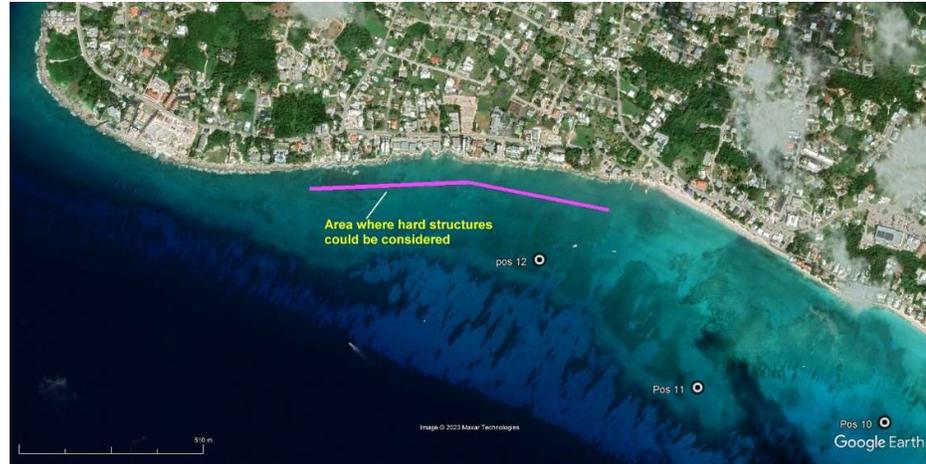
Figure 11-2 Area where hard structures could be considered – Northern part of SMB.

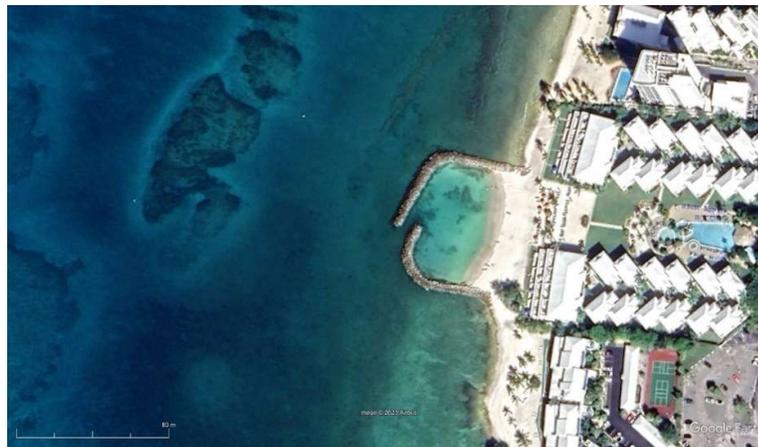
Figure 11-3 Coastal protection using hard structures: Cove at Treasure Island Resort.

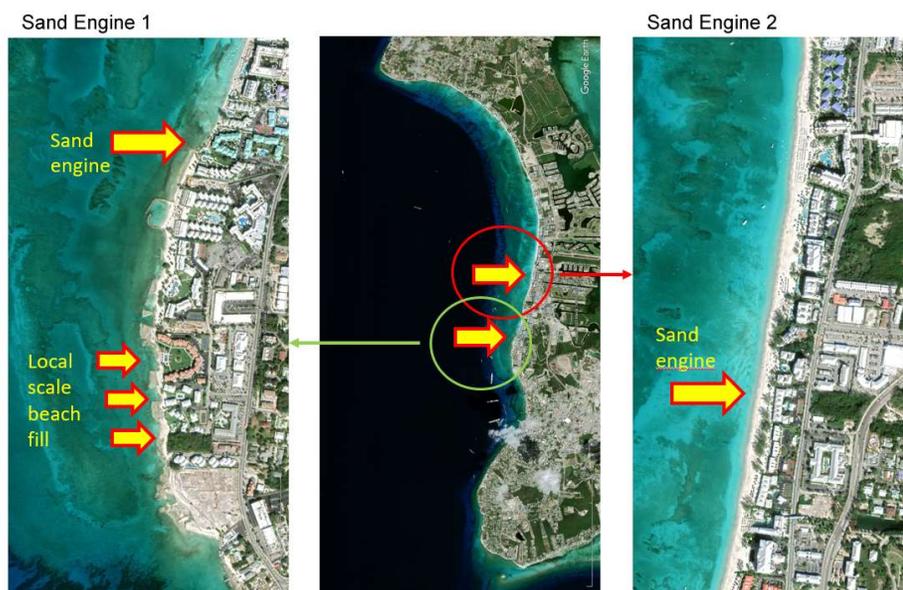
Figure 11-4 Beach nourishment layout with local scale beach fill in the southern part of SMB and two sand engines along the south/central section of the beach.

7. The best way to mitigate the erosion along SMB is through artificial beach nourishment. It is recommended to feed the sand to the beach in two designated spots in the southern part of SMB. These so-called sand engines will gradually feed the neighboring beaches. A major advantage of the use of sand engines instead of integral beach nourishment is that the establishment of the nourishment does not require the use of heavy machinery on the beach. The sand engines can be created using floating pipelines where sand is pumped directly from the dredger to the beach.

8. An initial nourishment volume of $200,000 \text{ m}^3$ sand is recommended, equally distributed between the two sand engines. The sand must be distributed along a 500m long stretch. The initial increase in beach width at the sand engine is around 40m. After the initial charging, the sand will gradually be dispersed by waves and currents to neighboring areas.

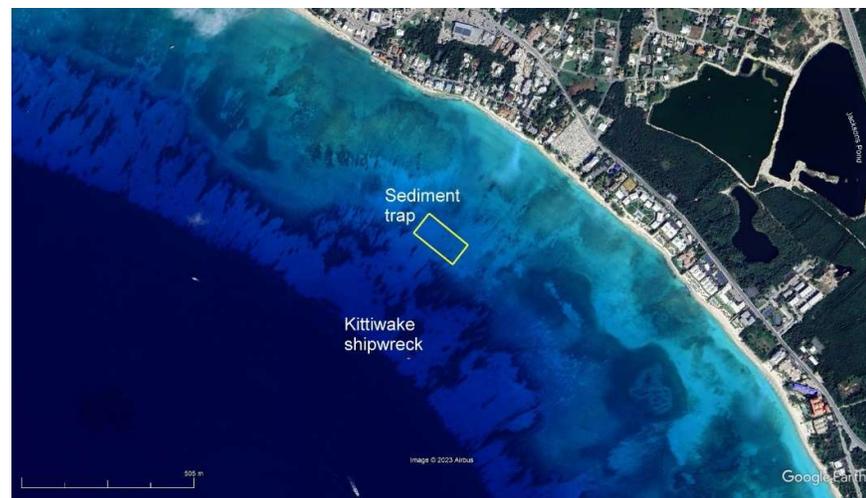
Figure 11-5 Possible location for a sediment trap

11. It is recommended to consider the use of sediment traps to re-use sand that is transported during hurricanes and reduce sediment loss to deep water. A sediment trap is a strategically located, dredged pit. Currents generated during storm events will carry the sediment to the traps where it is deposited.
